Holloway Park, London

Construction Monitoring Report

Client:	London Square
Ref:	CM51-22405-R0
Date:	31 October 2023
Note by:	Adam Bamford, BSc MIOA DipIOA, Principal Acoustics Consultant

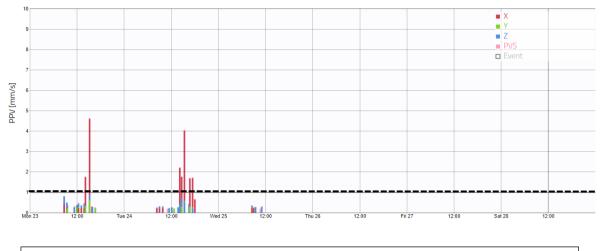
Location 1 - Time-history graph

- 4.3 With regards to vibration, there were:
 - 11 exceedances of the vibration trigger level of 1 mm/s PPV at Location 1
 - 31 exceedances of the vibration trigger level of 1 mm/s PPV at Location 2

Early exceedances would be due to the changing of the batteries and the others will all be nonconstruction related alerts - No active works carried out week commencing 23/10/23 in this area.

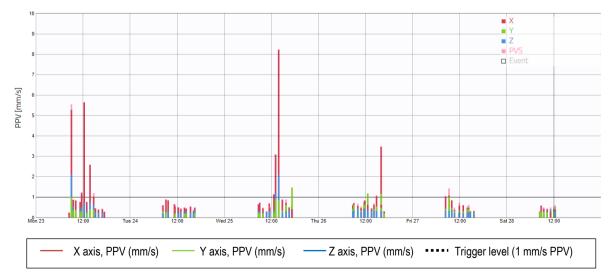
Early exceedances would be due to the changing of the batteries and the others will all be nonconstruction related alerts - No active works carried out week commencing 23/10/23 in this area.

We did have the hoarders Tag working here but the works were working away form the monitor. Also we had the investigation to the loss of power.

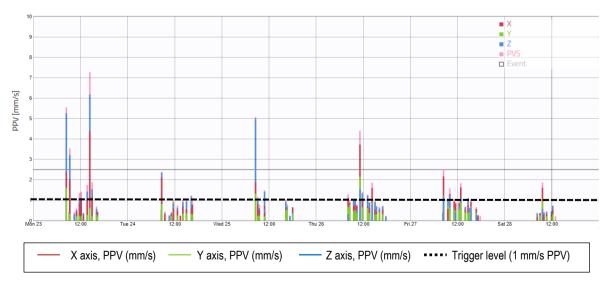
Location 3 – Time-history graph

- 66 exceedances of the vibration trigger level of 1 mm/s PPV at Location 3. It is worth noting however that these would be reduced to 10 exceedances if the revised onsite trigger level of 2.5 mm/s PPV was adopted as recommended by us following our attended offsite vibration monitoring as set out in TN02-22405-R) dated 20 September 2023. Of those 10 exceedances, 7 of them occurred when batteries were being changed by site operatives.

Early exceedances would be due to the changing of the batteries and the others will all be vehicles using the haul road as well as the collection of plant when being delivered - No active works carried out week commencing 23/10/23 in this area.

The alerts for between 3:30pm and 4:15pm were Horizon repairing the haul road with fresh crush as the lorries had worn down the original layers.

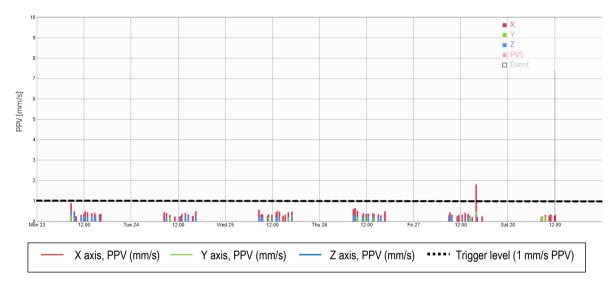
Location 4 – Time-history graph

• 1 exceedance of the vibration trigger level of 1 mm/s PPV at Location 4

No alerts - No active works carried out week commencing 23/10/23 in this area.
