Former Holloway Prison

Arboricultural Impact Assessment

October 2021

Barton Hyett Associates
Arboricultural Consultants

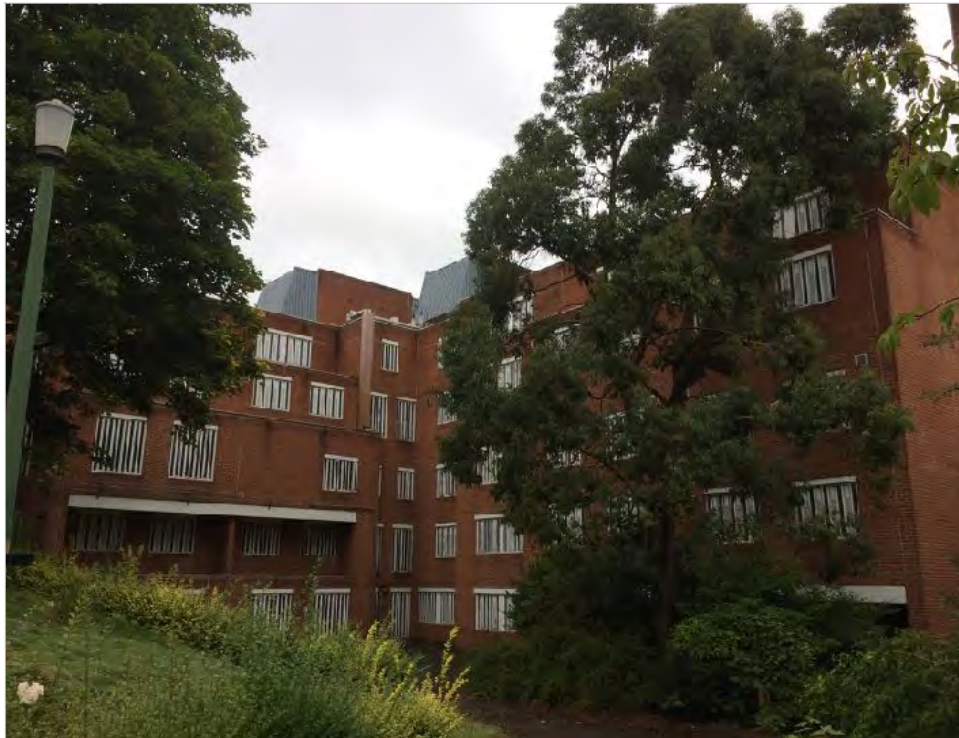
PHOTO 1: View of eucalyptus T14 (right) and sycamore T15 (left) looking north, showing the varying ground levels within the prison site.

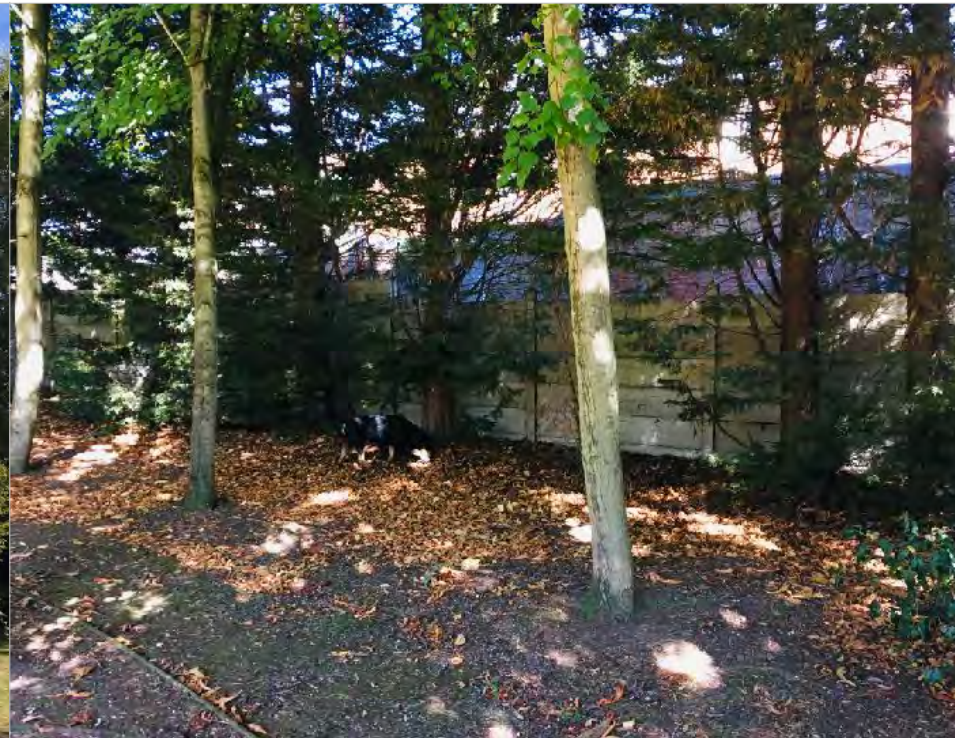
PHOTO 8: Detail of G12 Leyland cypresses and G13 small-leaved limes and their location close to the site boundary retaining wall, looking north.

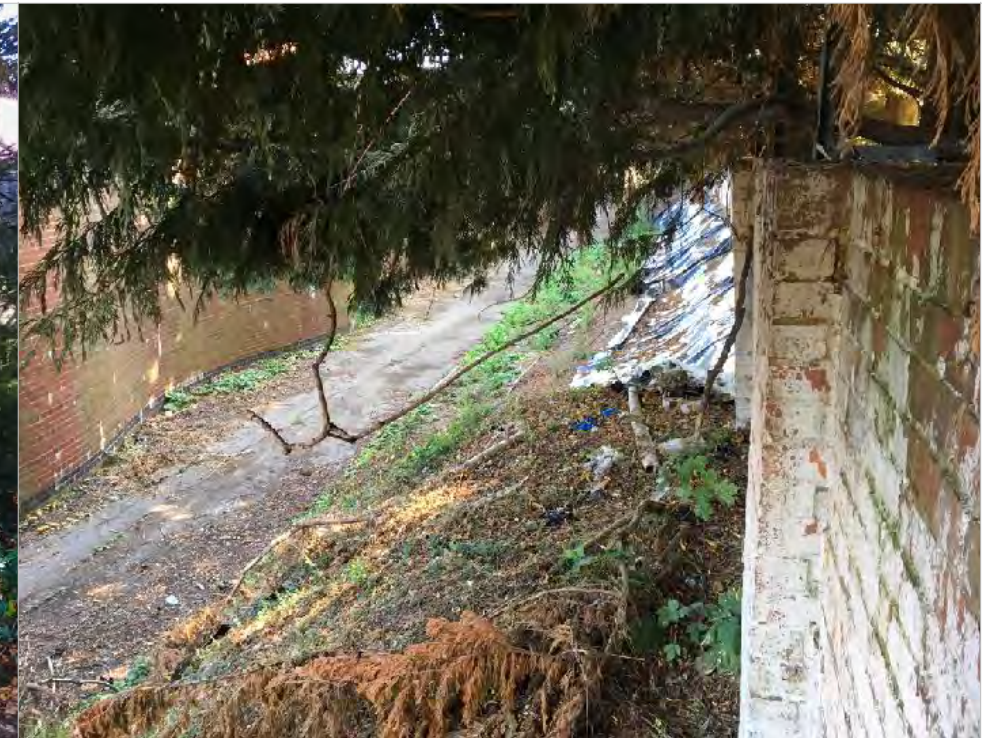
PHOTO 9: View over the Dalmeny Avenue garden boundary wall, looking south-east and showing the drop in ground level into the prison site.

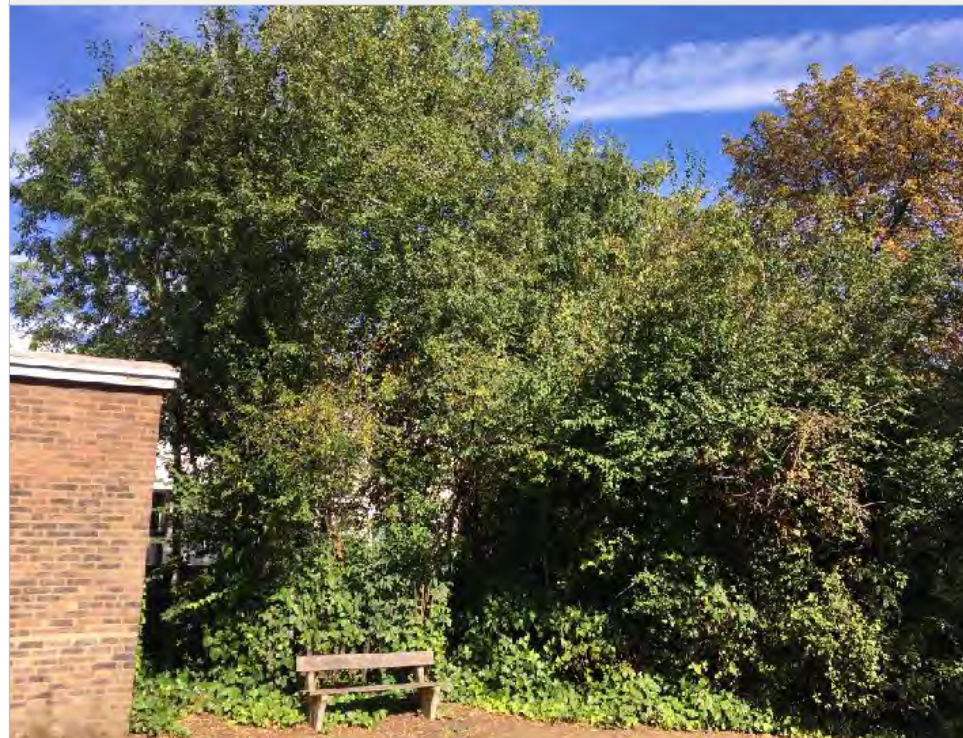
PHOTO 10: View of the proposed location of the new access to Trecastle Way from the rear garden of Dalmeny Avenue, looking north-west. Common ash T99 is on the left surrounded by damson and other semi-mature trees within G8. The top of horse chestnut T72 is visible distant-right.

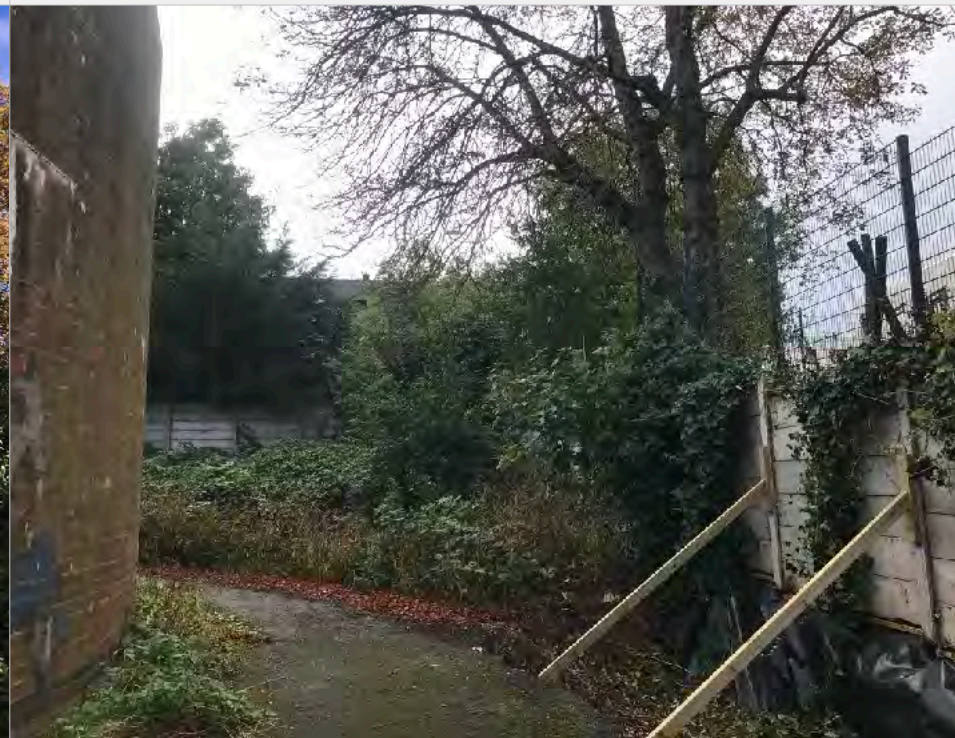
- 6.28. **Trecastle Way access:** Plot E building and the new Trecastle Way access are at the edge the RPAs of off-site horse chestnut T72 (B1) and common ash T75 (B2). At my last site visit I noted that knotweed removal excavations have already severed roots of T72 within the site, and my assessment is that additional minor excavations and ground level grading at the edge of the RPAs would have a low impact on the trees. It may be possible to design the new access structure using a non-invasive engineering solution so that the need for excavation into the existing ground level is minimised and gaseous exchange is maintained to the root systems.

PHOTO 11: View from within the site of the proposed location of the new access to Trecastle Way. Off-site horse chestnut T72 is the large tree on the right.

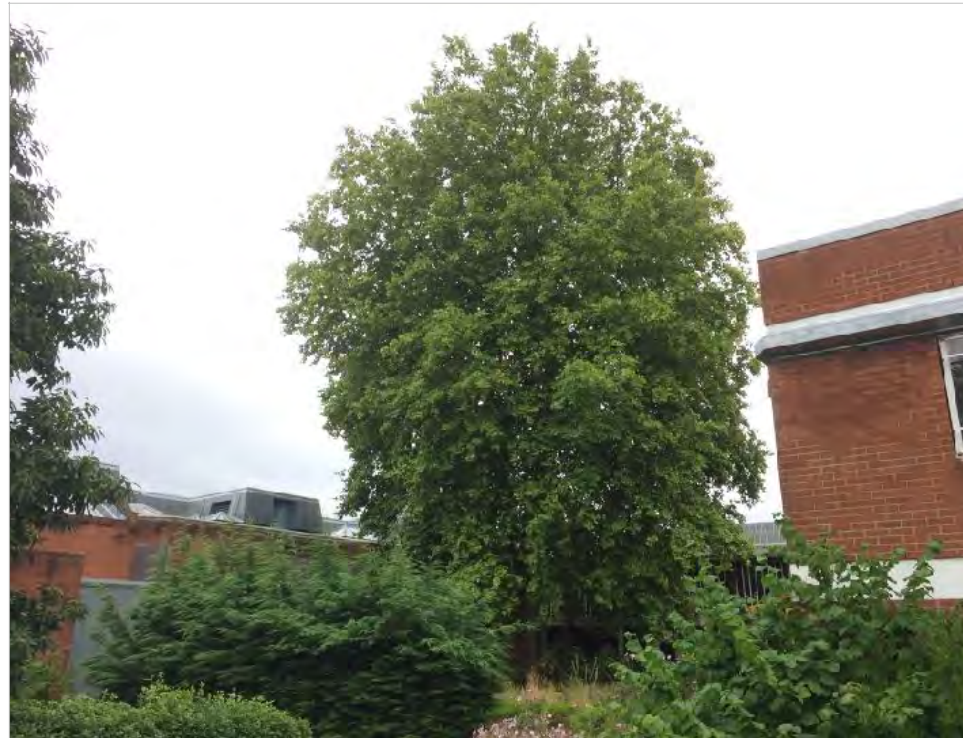
- 4.2. London Plane T51 is the only high-quality tree at the site. The upper part of its crown of this large tree is visible from the public highway. The tree is shown in images 13 and 14 (Section 4) and were taken in 2017 at the time of the initial tree survey. The tree is the largest within the site, both in terms of height and mass. The tree is of excellent form and condition. It grows within a square grass bed, with hard surfacing and building foundations within its root protection area (RPA).

IMAGE 13: View of category A London plane T51 in 2017, looking east.

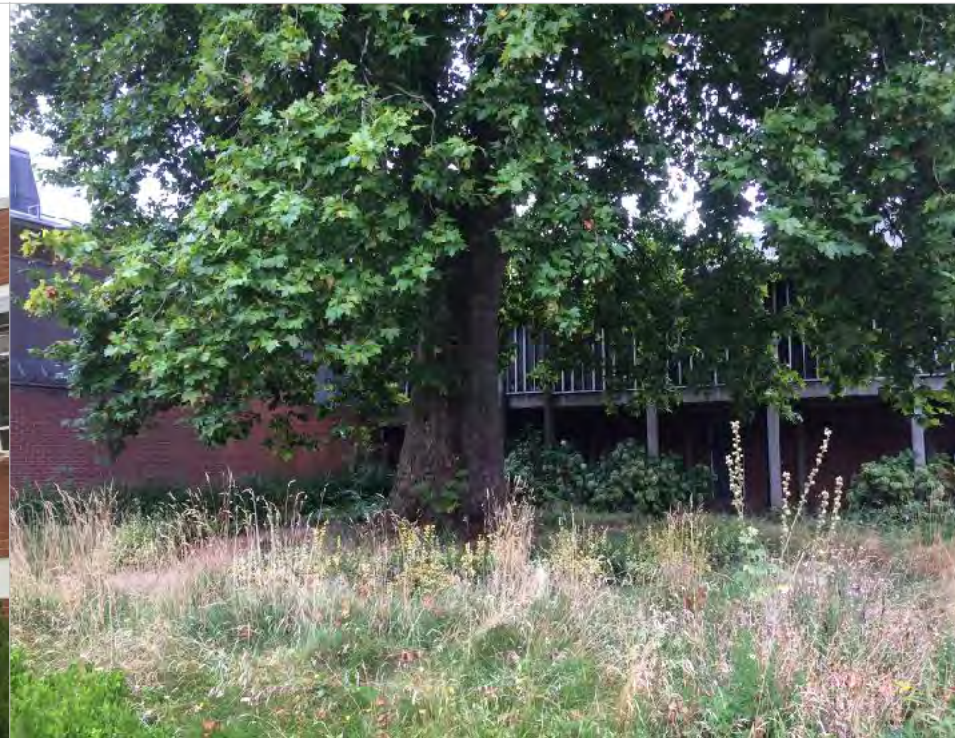
IMAGE 14: Detail of the lower part of plane T51 and its surroundings in 2017, looking east.

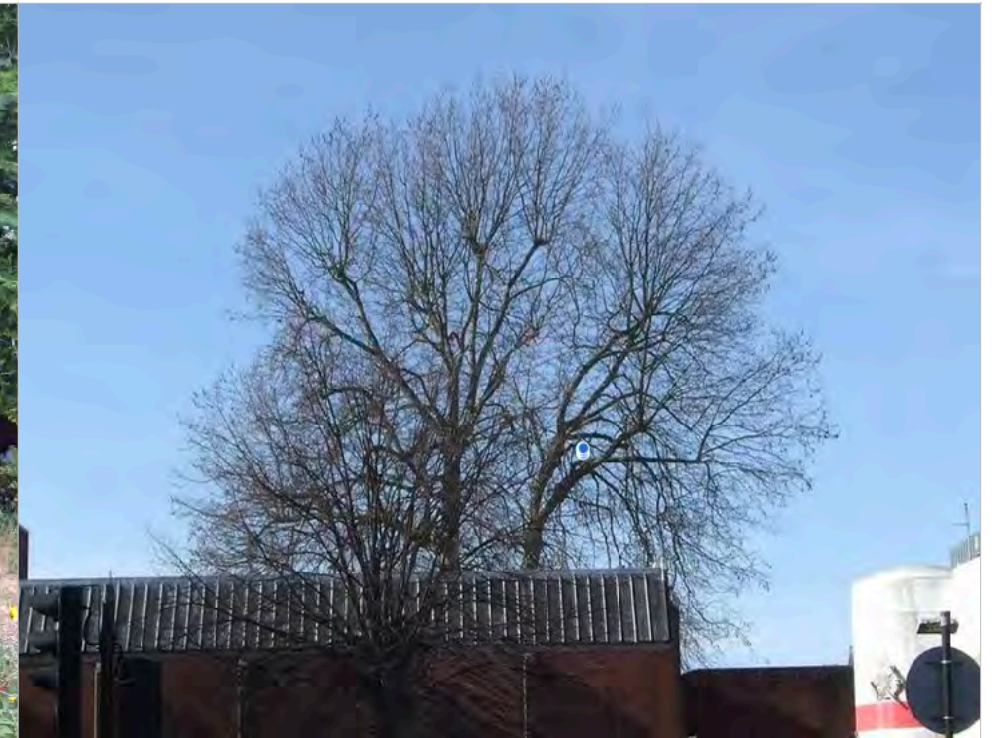
- 4.3. I have only seen the tree in full leaf. Online photographic research has found a photograph of the tree (by an unknown photographer) taken when the tree was not in leaf (image 15 in section 4). The photograph is taken from Camden Road, and clearly shows that the crown of the tree has been pruned in the past to reduce its height and spread. The pruning points can be seen as dense junctions of branches approximately 3-4 metres below the branch tips. I do not know when the pruning work was carried out, as the work would not have been regulated by the Local Planning Authority (LPA) at the time.

- 6.16. It is impossible to accurately predict the future growth rate of a tree. The interplay of climatic and environmental conditions and variations over time creates a highly-dynamic system. Ideal micro-climatic conditions will speed tree growth, and stress or damage to a tree's root system will slow growth. Vigorous trees in the UK, such as London plane, will typically grow between 15cm and 50cm per year. However, when branches are pruned the temporary reduction of apical dominance (regulated by growth hormones) causes a very rapid growth of shoots from latent buds within the remaining branch. This is the type of vigorous response growth seen after a London plane tree is pollarded, and is the growth pattern that is responsible for the dense branch junctions seen in image 15 of T51 in section 4.

IMAGE 15: Photo of T51 while not in leaf, taken from Camden Road, looking north-west. Note that the tree has been previously pruned to reduced its size. Photographer and date not known.
