# Holloway Park, London

## Construction Monitoring Non-Technical Summary

Client: London Square  
Ref: TN01-22405-R3  
Date: 11 December 2023  
Note by: Adam Bamford, BSc MIOA DipIOA, Principal Acoustics Consultant

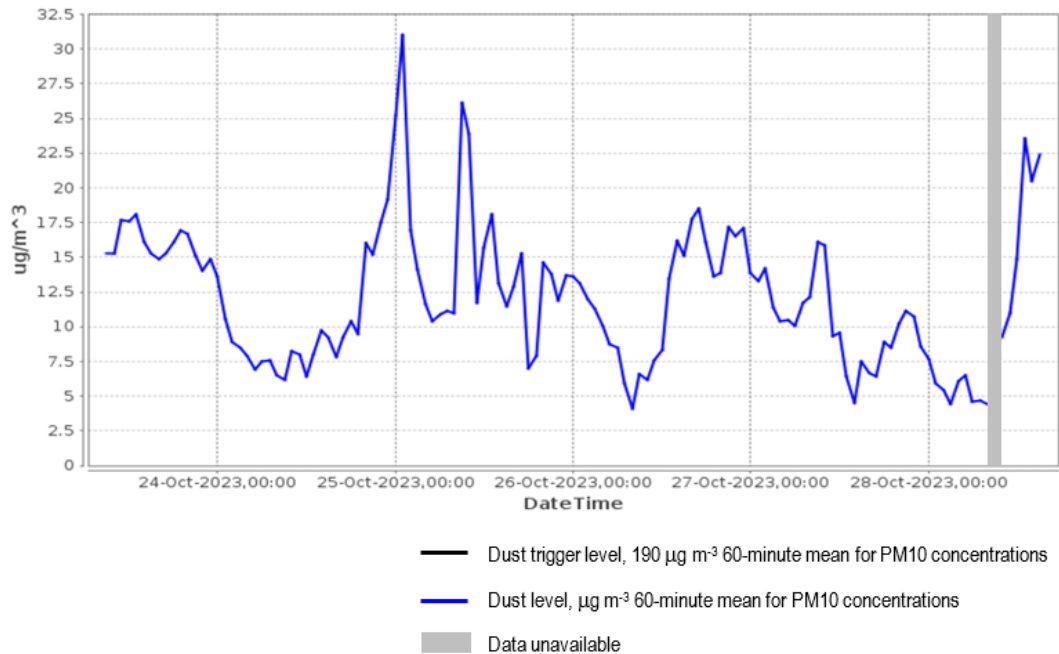
**Figure 2 – Example graph of dust monitoring at Holloway Park**

- 4.2 The vertical axis shows the measured dust emissions (PM10) measured in micrograms per cubic meter.
- 4.3 The horizontal axis shows the date and time of the measurements.

- 4.4 The blue coloured line shows the variation of PM10 concentrations over the recorded period.
- 4.5 The dust trigger limit would be denoted by a solid black line on the graph, if applicable. In the above example, the dust concentrations are so low they are well below the dust limit and therefore the dust limit is not shown. If there are any exceedances above the dust limit, then the project team will endeavour to explain what caused the exceedance(s) and what mitigation/management measures were taken onsite to reduce the exceedances.

- 4.6 Any gaps in the measured data will be denoted by a solid vertical shaded grey area as show in the figure above. Gaps in data will usually be caused by either power outages or a loss in mobile signal.

- 4.1 Figures 2, 3 and 4 below show examples of the dust, noise and vibration monitoring data that will be provided on the Holloway Park Community website and describes how this information can be interpreted.

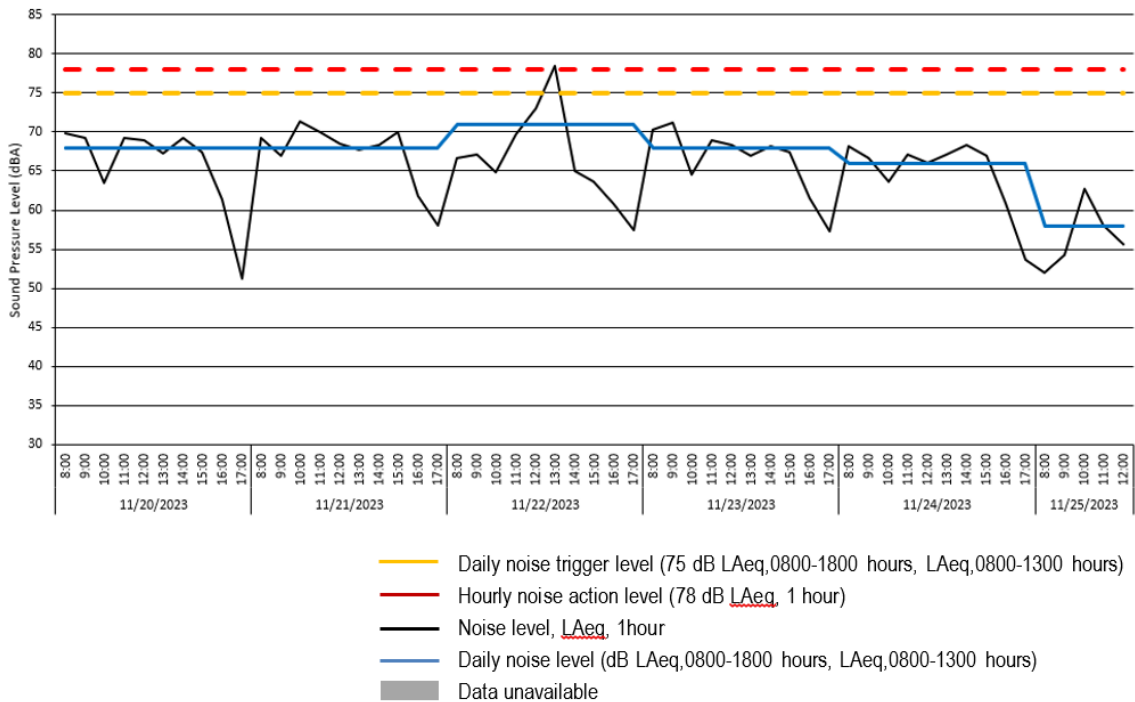
**Figure 3 – Example graph of noise monitoring from Holloway Park**

- 4.7 The vertical axis shows the measured noise levels (dB LAeq).
- 4.8 The horizontal axis shows the date and time of the measurements.
- 4.9 The solid blue line shows the daily measured noise level. For weekdays, this is a 10 hour value between 0800 and 1800 hours. For Saturdays, this is a 5 hour value between 0800 and 1300 hours.

- 4.10 The yellow dashed line shows the daily noise limit. In the example above there are no occasions where the blue line has gone above the yellow dashed line which means there were no exceedances of the daily noise limit.

- 4.11 The solid black line shows the hourly measured noise levels throughout the monitoring period.
- 4.12 The red dashed line shows the hourly noise limit. In the example above there is one occasion where the black line has gone above the red dashed line which means there was one exceedance of the hourly noise limit which occurred at 1300 hours on 22/11/2023.

4.14 Any gaps in the measured data will be denoted by a solid vertical shaded grey area as show in the figure above. Gaps in data will usually be caused by either power outages or a loss in mobile signal.

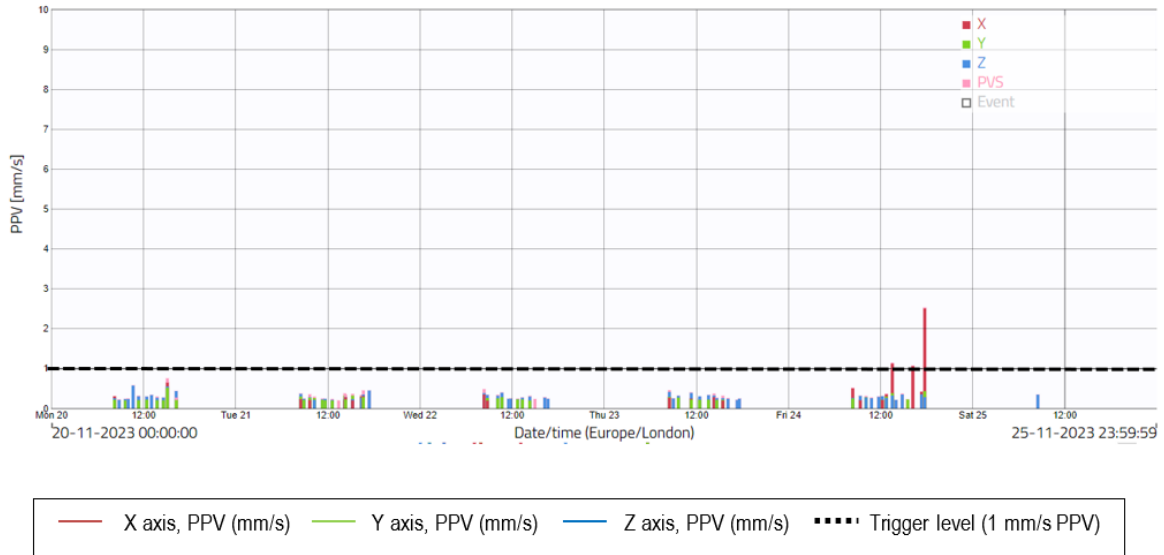
**Figure 4 – Example graph of vibration monitoring from Holloway Park**

4.15 The vertical axis shows the vibration (Peak Particle Velocity, PPV) measured in millimetres per second.

4.16 The horizontal axis shows the date and time of the measurements.

4.17 The solid red, green and blue lines show the measured horizontal and vertical PPV.

4.18 The black dashed line shows the vibration limit. In the example above there were exceedances of the vibration limit that occurred on Friday 24<sup>th</sup> November.

4.19 Any gaps in the measured data will be denoted by a solid vertical shaded grey area as show in the figure above. Gaps in data will usually be caused by either power outages or a loss in mobile signal.

4.20 It should be noted that the weekly vibration summary graph will be compressed as data is recorded every minute onsite and this cannot be shown completely on a single graph at a weekly resolution.

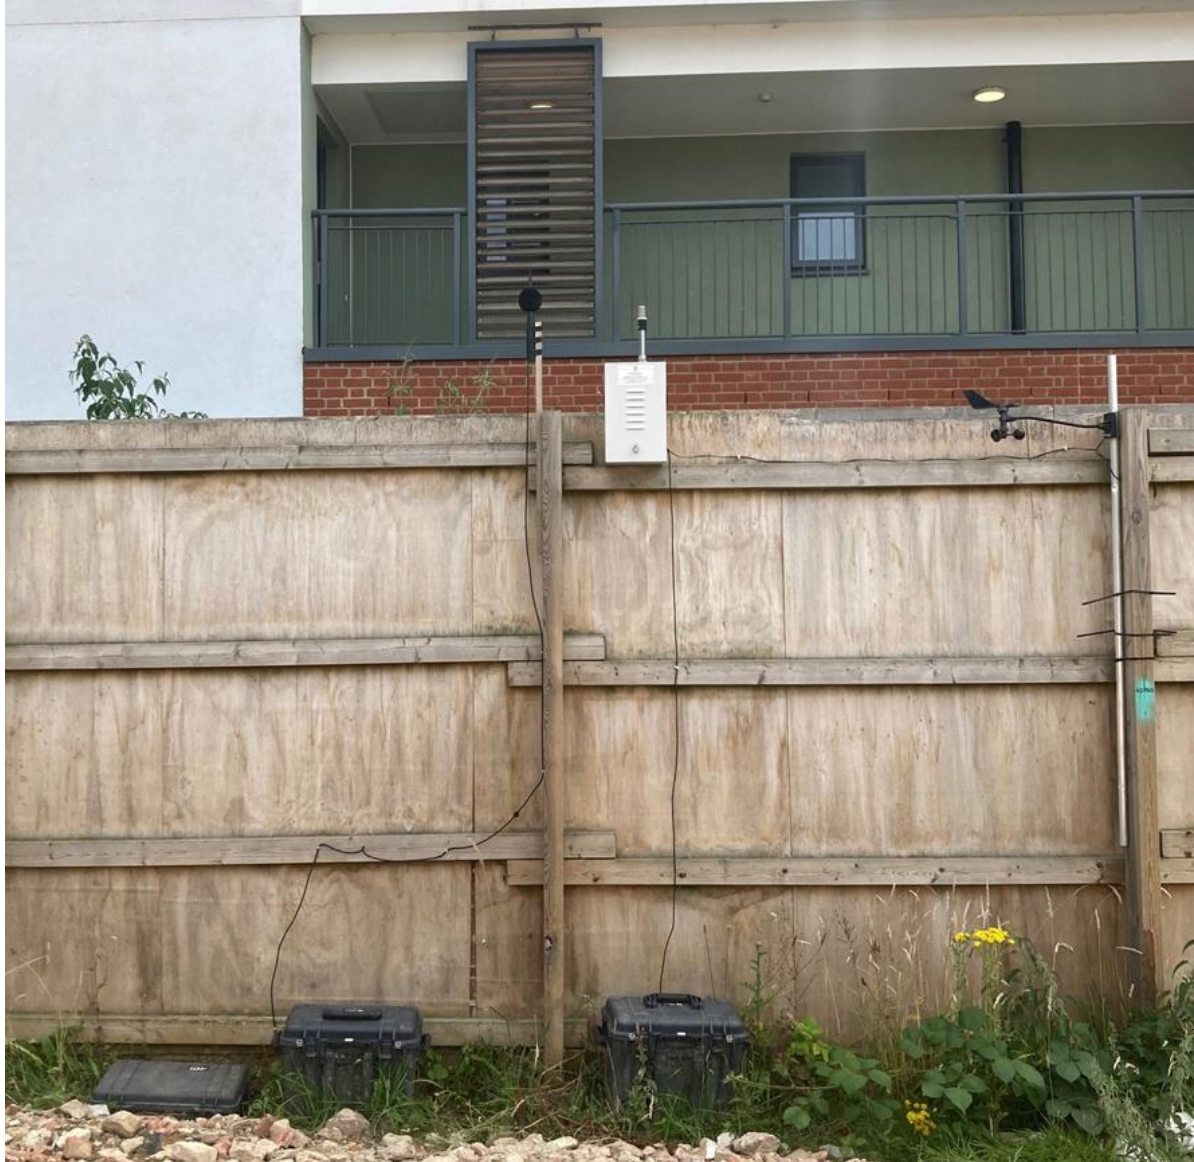
**Location 1 – Dust and Noise – southern boundary facing residential uses on Dalmeny Avenue**

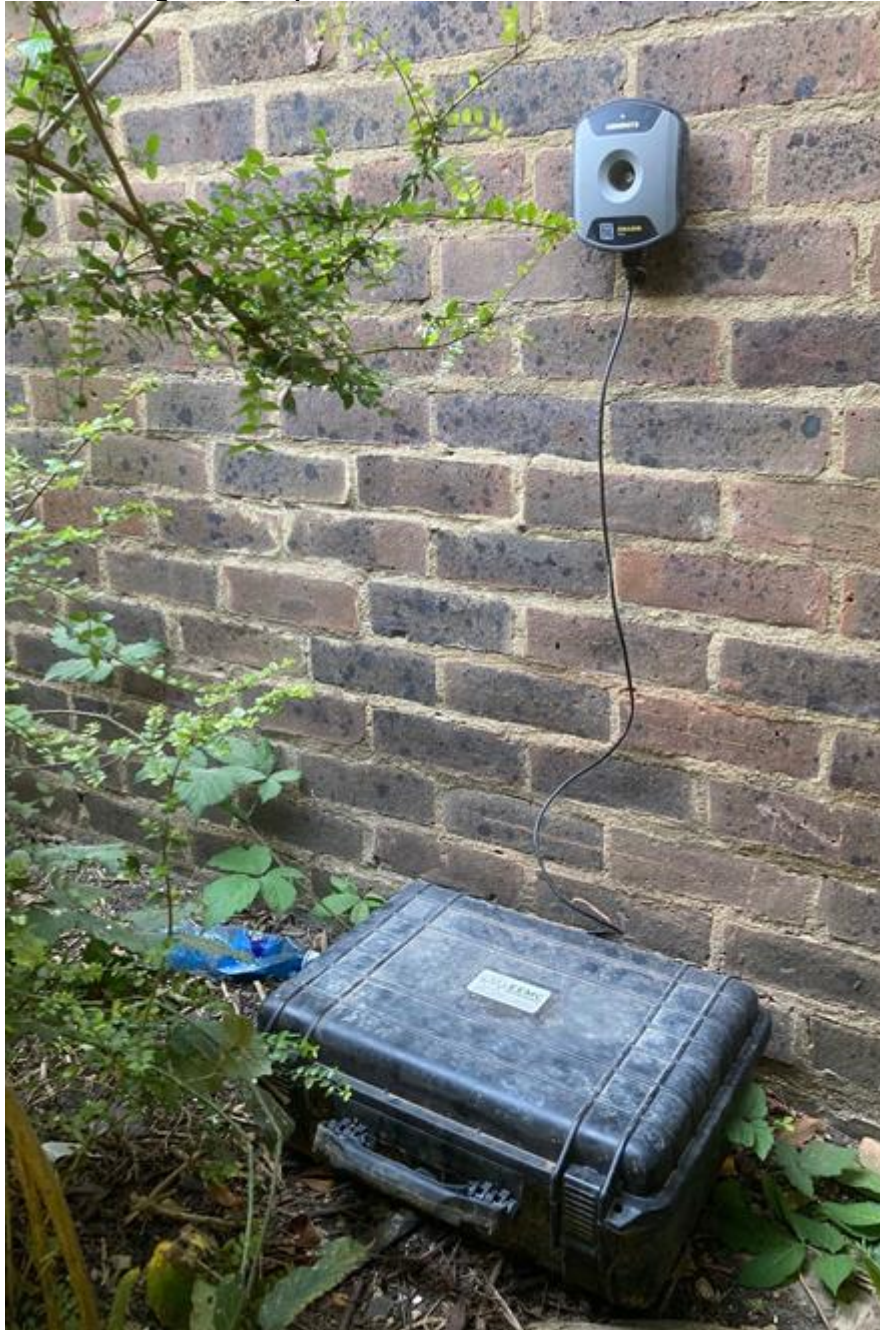
**Location 1 – Vibration – offsite – attached to facade of one of the residential flats within Dalmeny Avenue facing the development**

- 2.4 On 8<sup>th</sup> June 2023, the vibration monitor installed at Location 1 was relocated to the facade of the residential property. This was undertaken with the project Environmental Health Officer at Islington Council and a member of the Residents Association present. The monitor was relocated to accurately record vibration levels relevant to nearby residential receptors.

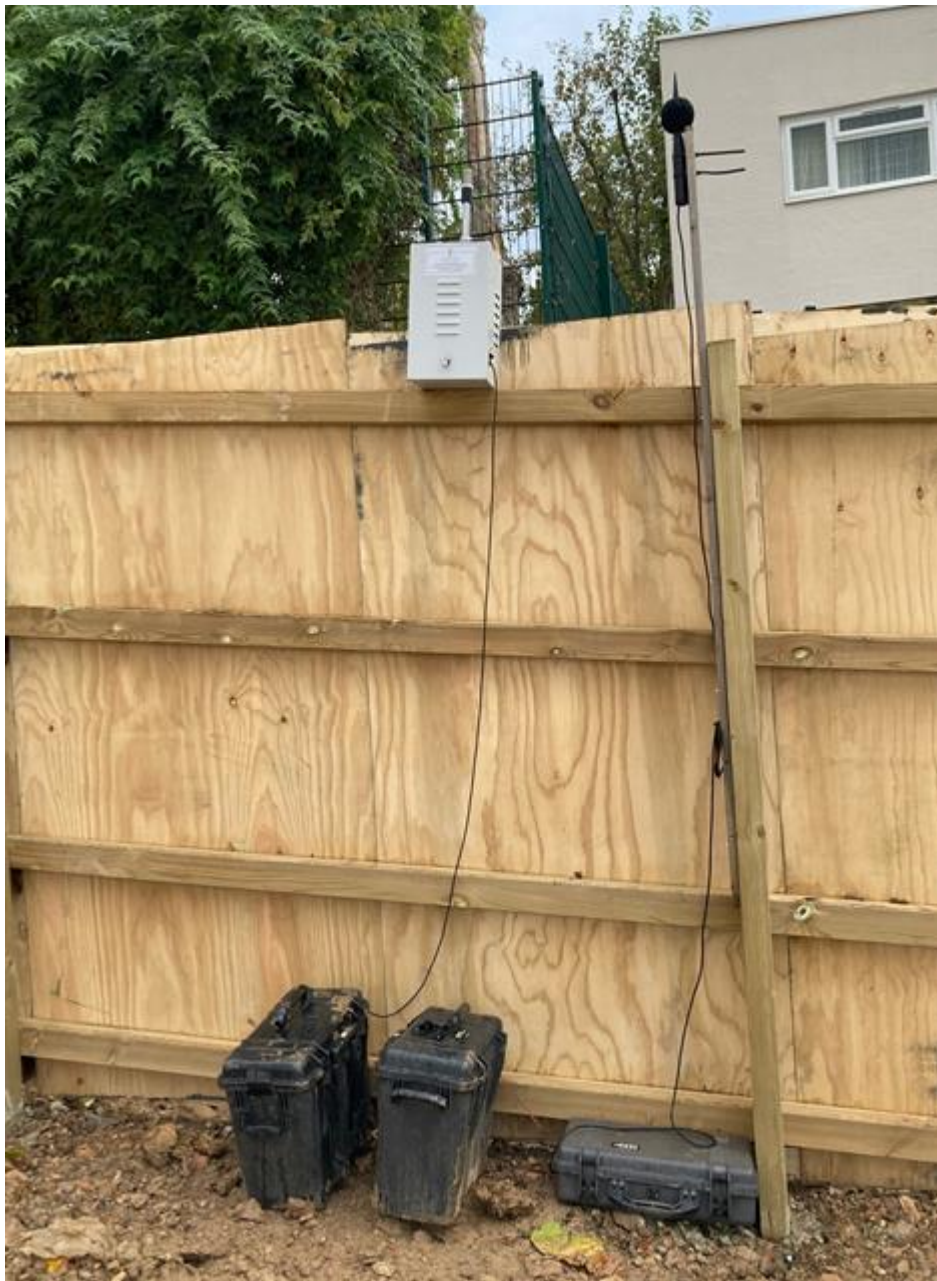
**Location 2 – Dust, Noise and Vibration – northern boundary facing residential uses on Penderyn Way**

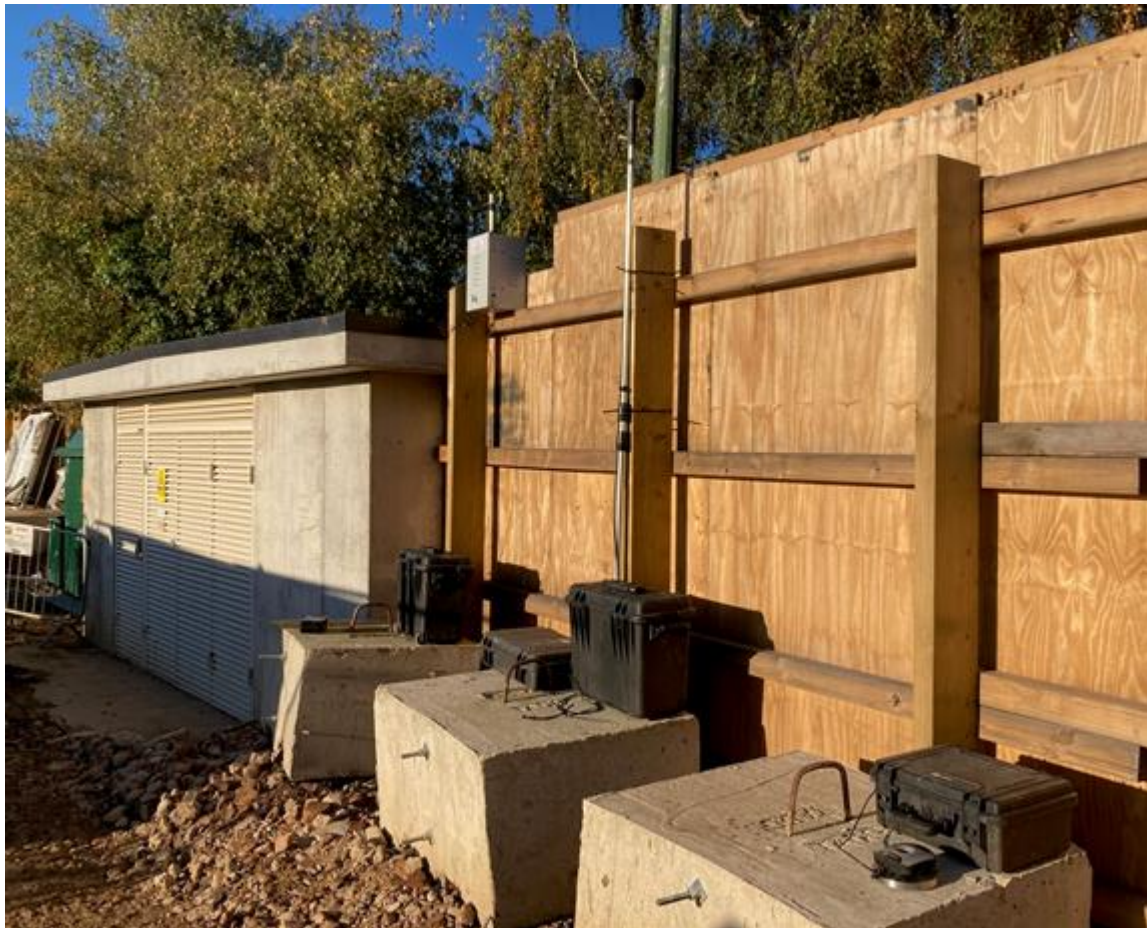
**Location 3 – Dust, Noise and Vibration – north eastern boundary facing residential uses within Holloway Estate**

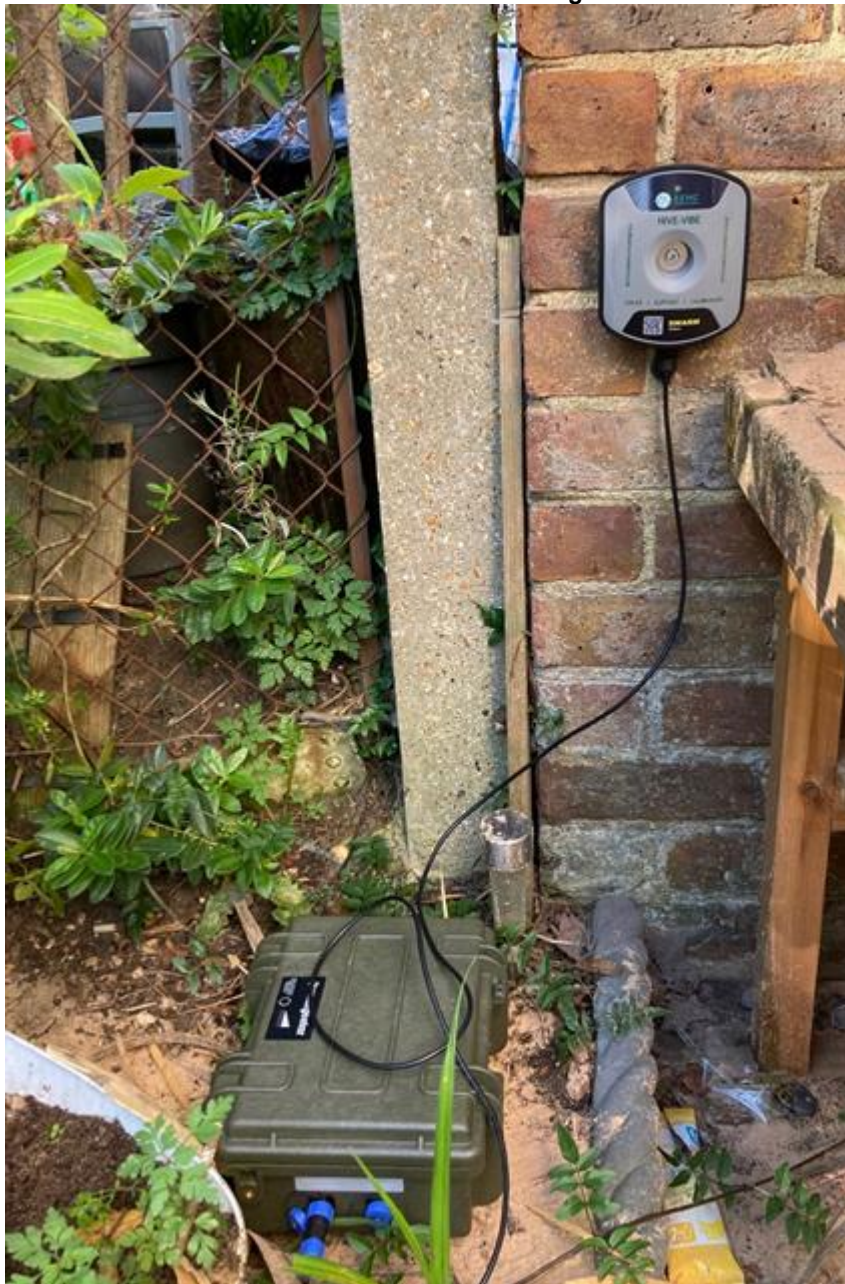
Location 4 – Vibration – offsite – attached to rear garden fence of one of the dwellings on Treacastle Way

- Finally, a further vibration monitoring unit was installed on 23<sup>rd</sup> August 2023 within the boundary of one of the dwellings at Trecastle Way following a residents' request (this is Location 4).
