Appendix B Factual Report

Document Control Form		
PROJECT	HMP HOLLOWAY		
REPORT NAME	FACTUAL GEO-ENVIRONMENTAL REPOPRT		
REPORT REFERENCE	GRO-20291-2206		
STATUS	FINAL		
ISSUE DATE	26 FEBRUARY 2021		
	1.1	06 APRIL 2021	
REVISION			
CLIENT	WATERMAN I&E		
CLIENT CONTACT	FREDDIE ALCOCK		
For and Behalf of Groundtech Consulting			
SIGNATURE	B Muse		
AUTHOR	Bradley Massey BSc (Hons) FGS		
SIGNATURE	R. Wares		
CHECKED	Richard Wyatt MEng (Hons) FGS		
SIGNATURE	leles		
REVIEWED	James Doyle BSc (Hons) CGeol FGS

Groundtech Consulting Limited have been instructed by Waterman I&E to undertake a Ground Investigation on the now disused HMP Holloway Prison in Holloway, London. The investigation was conducted in accordance with BS 5930:2015, BS 10175:2017, BS 8576:2013 and BS 22475.

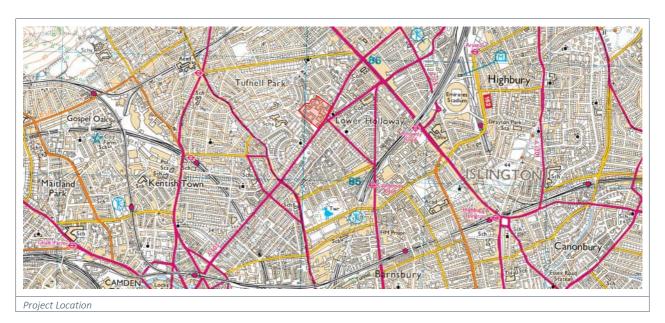
The site is located circa 2.3km north east of the London Borough of Islington, as shown on the Project Location Plan *GRO-20291-P01* and is approximately centred on National Grid Reference 530098, 185591.

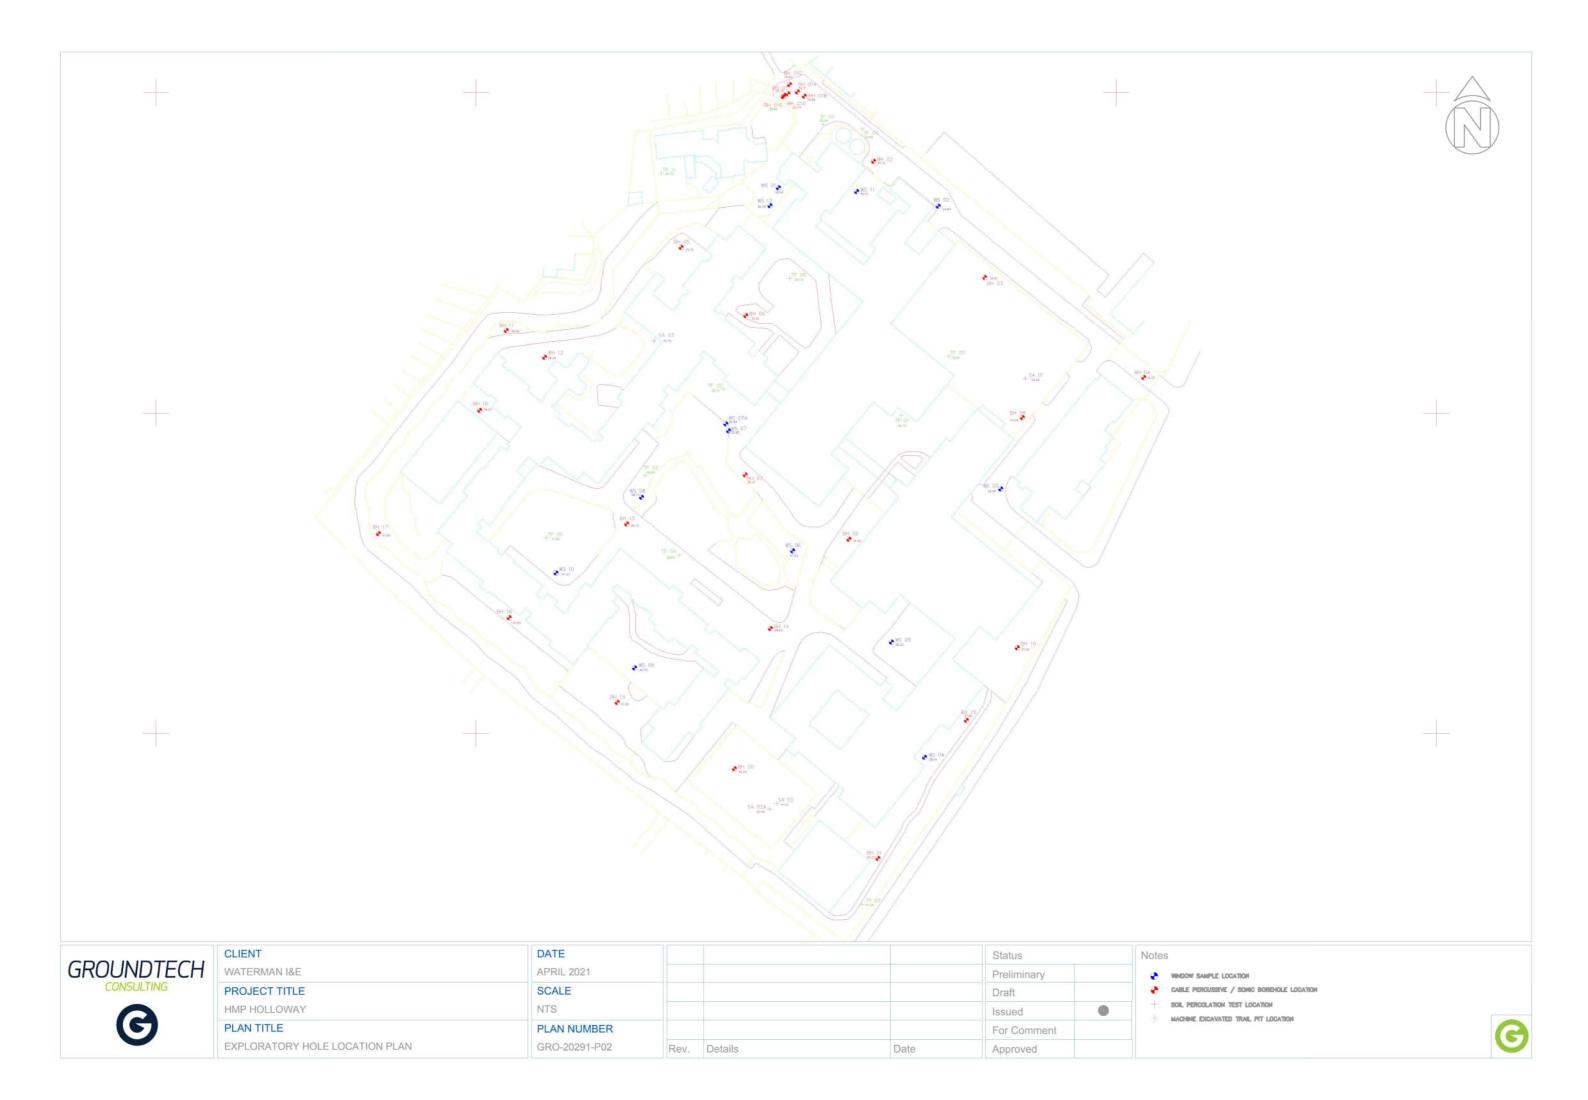
The exploratory hole locations are presented on Groundtech Plan *GRO-20291-P02* and the exploratory hole logs are presented in *Appendix 3*. The locations and elevations of the exploratory hole locations were surveyed in on completion of the Ground Investigation and are presented on the exploratory logs.

Plans		
Plan Reference	Revision	Title
GRO-20291-P01	-	Project Location Plan
GRO-20291-P02	-	Exploratory Hole Location Plan
