Former Holloway Prison Contamination - Preliminary Environmental Risk Assessment

Preliminary Environmental Risk Assessment

Former Holloway Prison, London

Document Reference: WIE16172-100-R-1.3.1-PERA

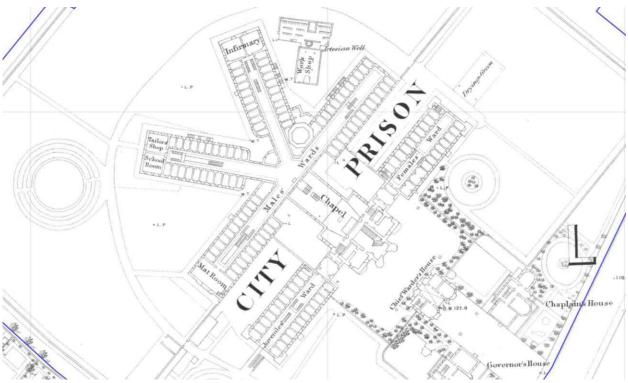
Figure 2: Historical Site Use

Source: Groundsure MapInsight, 1872, 1056 Town Scale Plan, 1: 1,056.

A review of historical maps obtained from Groundsure has been undertaken. Table 3 summarises the relevant information.

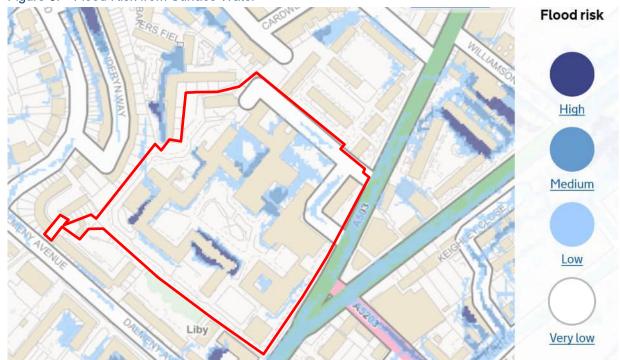
Figure 3: Flood Risk from Surface Water

The EA's indicative flooding data indicates the Site is located in an area at risk of surface water flooding. Areas with a low and medium risk of flooding are located in the north-eastern half, areas of low, medium and high risk flooding are located in the south-western half.

Source: https://flood-warning-information.service.gov.uk/long-term-flood-risk/map, accessed 09/09/19

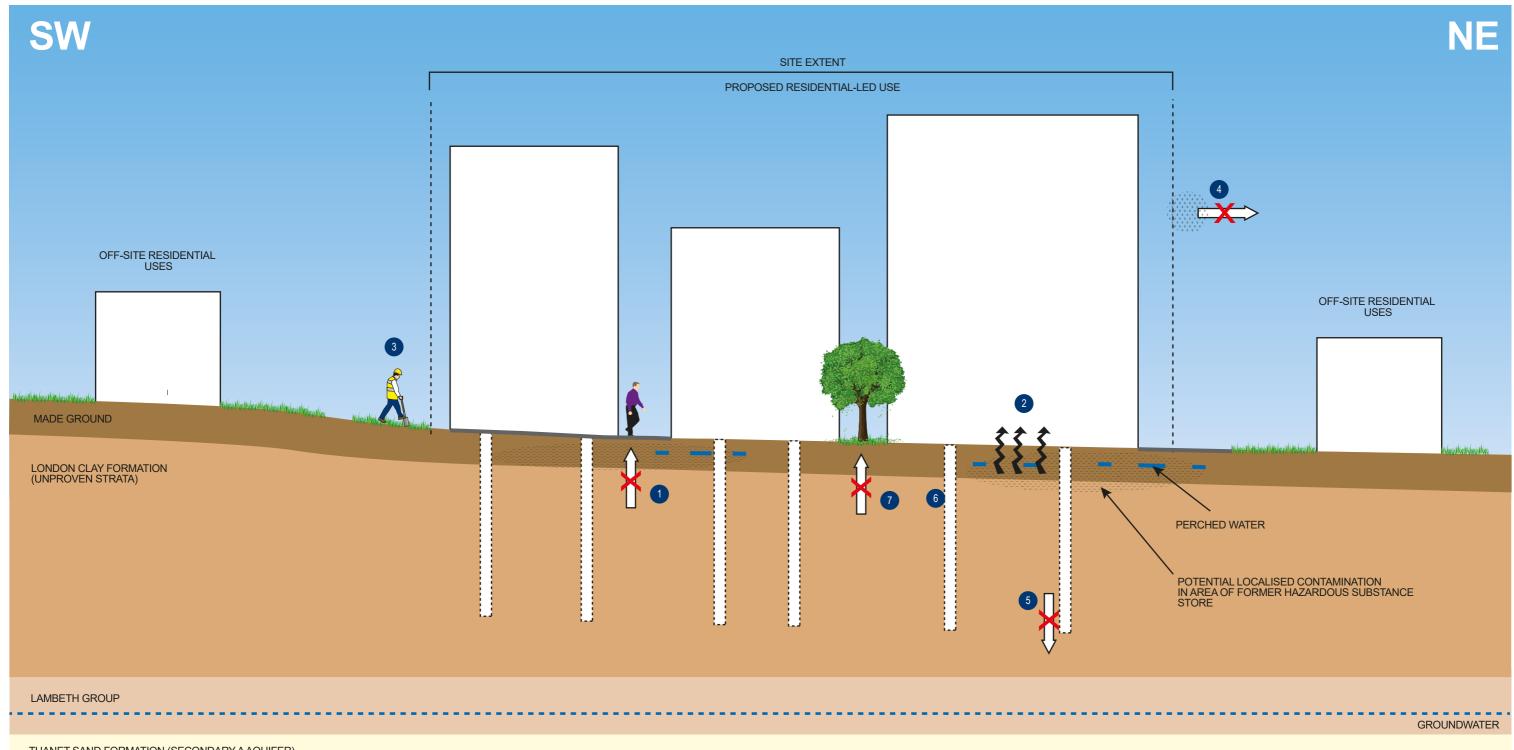
THANET SAND FORMATION (SECONDARY A AQUIFER)

SEAFORD CHALK FORMATION (PRINCIPAL AQUIFER)

Potential deep groundwater contamination pathway blocked by London Clay Formation. Foundations are likely to terminate in the London Clay Formation.

The results of ground investigation should be used to determine the design specification of buried foundations and services..
