Air Monitoring Report

Trac Laboratories Limited

Name and address of Client:		Horizon Environmental Ltd Ovenden House Wilcox Close Aylesham CT3 3EP	
Name and address of Site:		Holloway Park Parkhurst road Holloway N7 0SF N7 0SF	
Air test ref:	DQ12	Report issue date:	13 Dec 2023
Date of works:	13 Dec 2023	Report issue time:	
Removal contractor	Horizon Environmental Ltd		
Scope of works:	Air testing to be conducted during land remediation. 1. Personals on all ops machine and picking station during land remediation. 2. Back ground monitoring around site.		
Location of Work area:	Perimeter monitoring during land remediation.

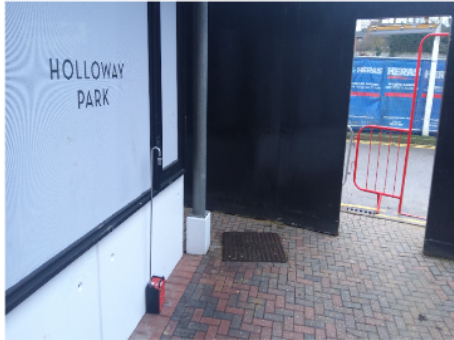
Date and time: 13/12/2023 09:35:28
Comments: DQ2069 Perimeter Air Monitoring

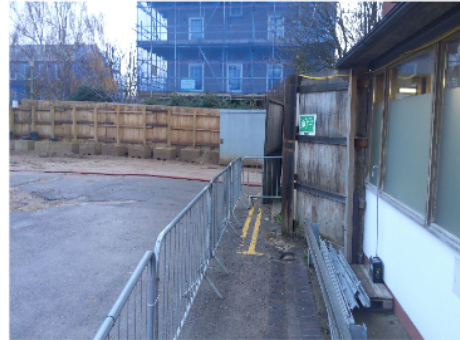
Date and time: 13/12/2023 09:38:26
Comments: DQ2070 Perimeter Air Monitoring

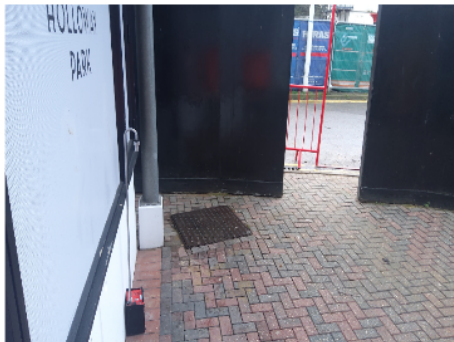
Microscope No:			PCM 028	Stage Micrometer ref	SM 033	Time piece ref:		NPL Test slide ref:	NPL 033	Relevant bands visible:	Yes					
Slide storage box no:			CB/10	Exposed Filter diameter:	22.0	Hi flow meter ref:	HF 011	Low flow mater ref:	LF 011	Graticule diameter:	102µm					
Sample No	Test Type	Sample Ref / Location	Pump No	Cowl No	Sampling period			Flow rate			Valume Litres	No of Fields	Fibres	Concentration f/ml	Reported result	Limit of Quantification
					Start time	Finish time	Total time (mins)	Start	End	Corrected						
1	FB	DQ002068 / Field Blank	N/A	CO115	N/A	N/A	0	N/A	N/A	0.0	0	N/A	N/A			
2	Background	DQ002069 / Perimeter	HV 028	CO116	09:34	10:40	66	8.0	8.0	8.0	528	200	0	0.00	<0.010	0.010
3	Background	DQ002070 / Perimeter	HV 082	CO117	09:37	10:42	65	8.0	8.0	8.0	520	204	2	0.0009	<0.010	0.010
4	Background	DQ002071 / Perimeter	HV 028	CO119	10:41	11:42	61	8.0	8.0	8.0	488	204	2	0.0009	<0.010	0.010

Date and time: 13/12/2023 10:41:45
Comments: DQ2071 Perimeter Air Monitoring

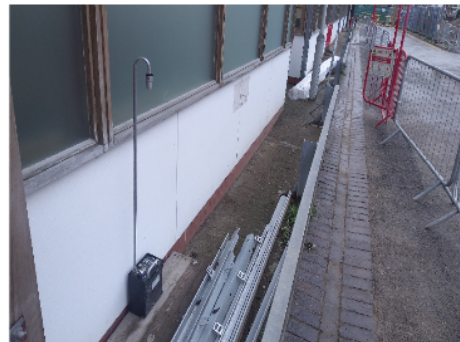
5	Background	DQ002072 / Perimeter	HV 082	CO120	10:43	11:45	62	8.0	8.0	8.0	496	200	5	0.0023	<0.010	0.010

Date and time: 13/12/2023 10:43:17
Comments: DQ2072 Perimeter Air Monitoring

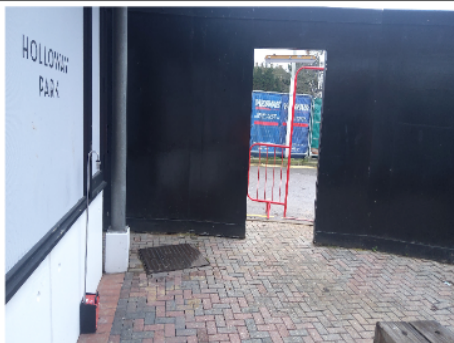
Date and time: 13/12/2023 11:45:19
Comments: DQ2073 Perimeter Air Monitoring

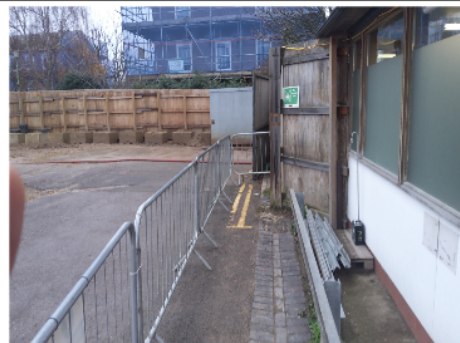
Microscope No:		PCM 028	Stage Micrometer ref	SM 033	Time piece ref:		NPL Test slide ref:	NPL 033	Relevant bands visible:			Yes				
Slide storage box no:		CB/10	Exposed Filter diameter:	22.0	Hi flow meter ref:	HF 011	Low flow mater ref:	LF 011	Graticule diameter:			102µm				
Sample No	Test Type	Sample Ref / Location	Pump No	Cowl No	Sampling period			Flow rate			Valume Litres	No of Fields	Fibres	Concentration f/ml	Reported result	Limit of Quantification
					Start time	Finish time	Total time (mins)	Start	End	Corrected						
6	Background	DQ002073 / Perimeter	HV 028	CO122	11:44	13:07	83	8.0	8.0	8.0	664	200	4	0.0014	<0.010	0.010
7	Background	DQ002074 / Perimeter	HV 082	CO123	11:46	13:08	82	8.0	8.0	8.0	656	205	5	0.0017	<0.010	0.010

Date and time: 13/12/2023 11:47:15
Comments: DQ2074 Perimeter Air Monitoring
