Holloway Park, London

Construction Monitoring Non-Technical Summary

Client: London Square
Ref: TN01-22405-R6
Date: 8 October 2024
Note by: Anthony Coraci, MSc DipIOA MIOA, Senior Acoustics Consultant

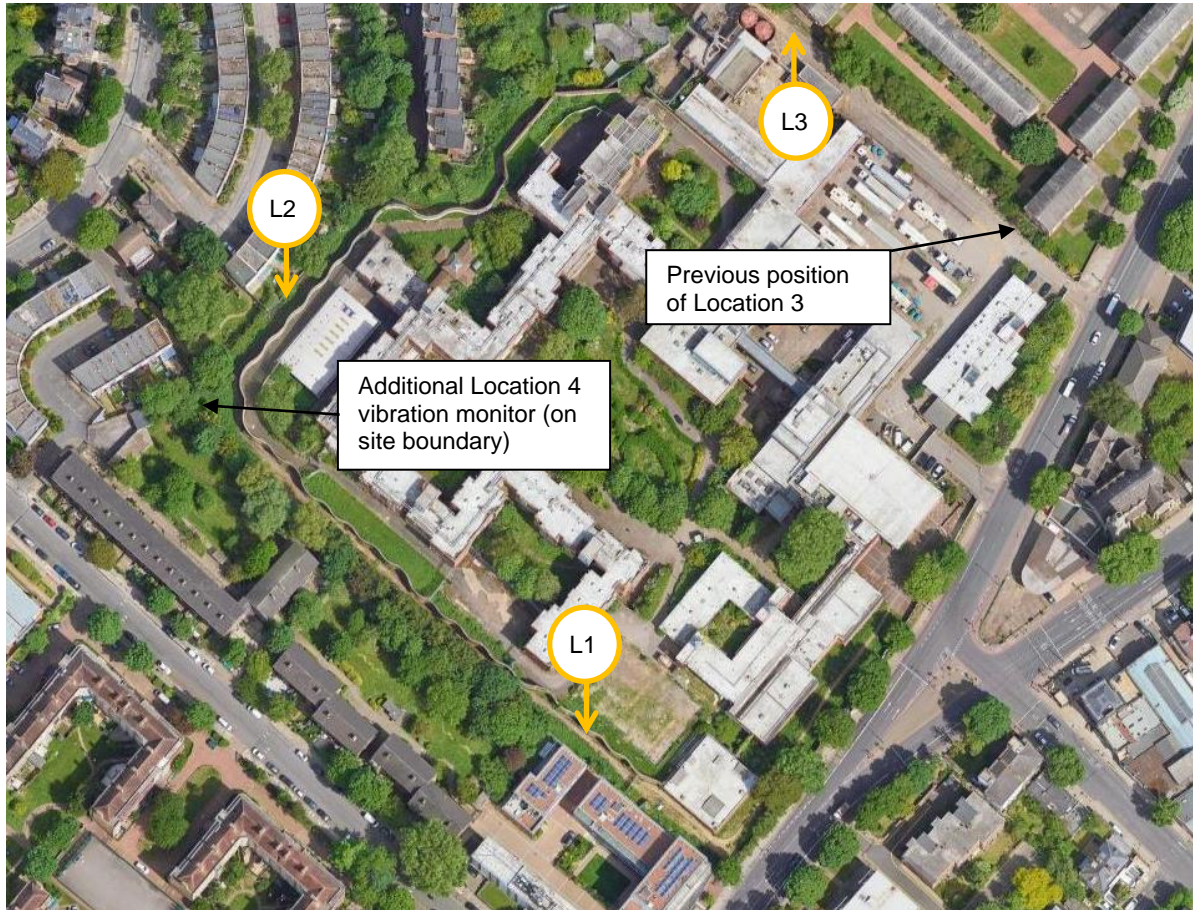
Figure 1 Construction Monitoring Locations

- An initial installation was carried out on 21st October 2022. This comprised the installation of the dust, noise and vibration monitor at Location 1 and the vibration monitor at Location 2 (refer to Figure 1 on page 4).
- A further installation was carried out on 8th November 2022 which included the installation of the dust and noise units at Location 2 (refer to Figure 1).
- A further installation was carried out on 28th June 2023 which included the installation of dust, noise and vibration units at Location 3.

- An additional vibration monitor is in place along the north-western boundary of the site, which is shown as Location 4 in Figure 1 below. The monitor was moved to this location on 17th May 2024. This monitor was previously located within the boundary of one of the dwellings at Trecastle Way following a residents' request, from 23rd August 2023 onwards. The monitor was moved to its current location (along the site boundary) at the request of this resident.

- The monitors at Location 3 were moved to a new position during a site visit carried out by Cass Allen, on 26th September 2024. Prior to the site visit, the updated location was agreed with site management, as well as Islington Borough Council's EPPP Team.

- 2.3 A plan showing the monitoring locations are shown in Figure 1 (also showing the previous position of Location 3) and in-situ photographs of the monitoring installations are provided in Attachment 1 at the end of this note. These locations were discussed with the project team prior to installation and were advised by Cass Allen.

- 2.4 On 8th June 2023, the vibration monitor installed at Location 1 was relocated to the facade of the residential property. This was undertaken with the project Environmental Health Officer at Islington Council and a member of the Residents Association present. The monitor was relocated to accurately record vibration levels relevant to nearby residential receptors.

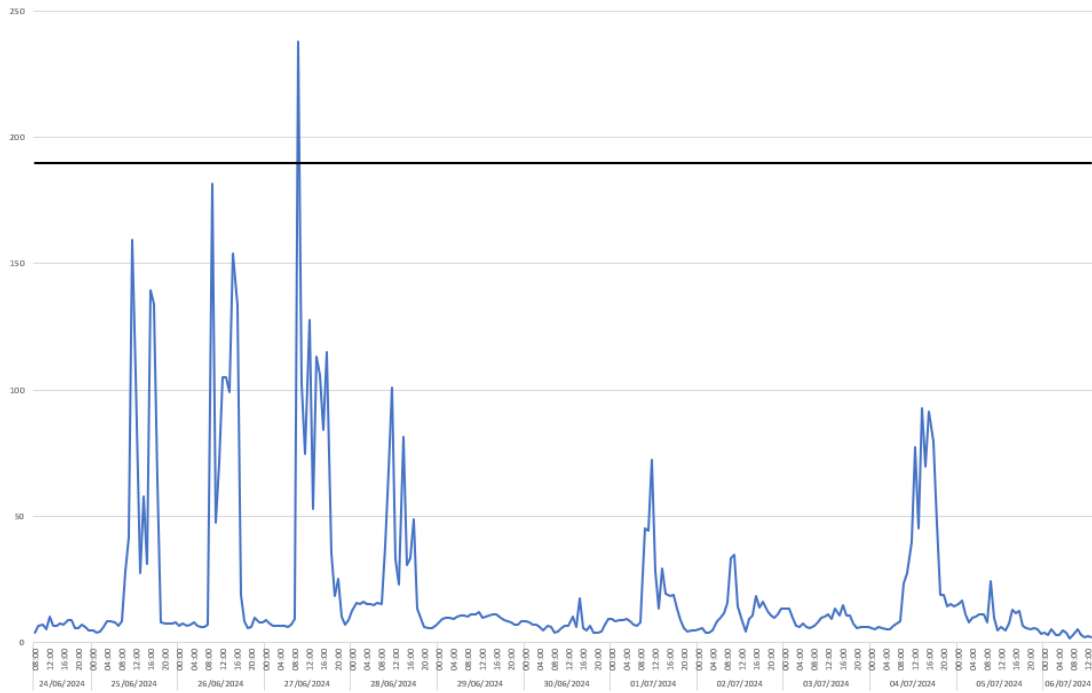
Figure 2 – Example graph of dust monitoring at Holloway Park

- 4.2 The vertical axis shows the measured dust emissions (PM10) measured in micrograms per cubic meter.
- 4.3 The horizontal axis shows the date and time of the measurements.
- 4.4 The blue coloured line shows the variation of PM10 concentrations over the recorded period.
- 4.5 The dust trigger limit would be denoted by a solid black line on the graph, if applicable. In the above example (refer Figure 2), a single exceedance of the dust limit of $190 \mu\text{g m}^{-3}$ is shown. The project team will endeavour to explain what caused any exceedance(s) shown in the monitoring reports, and what mitigation/management measures were taken onsite to reduce the exceedances.
- 4.6 Any gaps in the measured data will be denoted by a solid vertical shaded grey area as show in the figure above. Gaps in data will usually be caused by either power outages or a loss in mobile signal.

- 4.1 Figures 2, 3 and 4 below show examples of the dust, noise and vibration monitoring data that will be provided on the Holloway Park Community website and describes how this information can be interpreted.

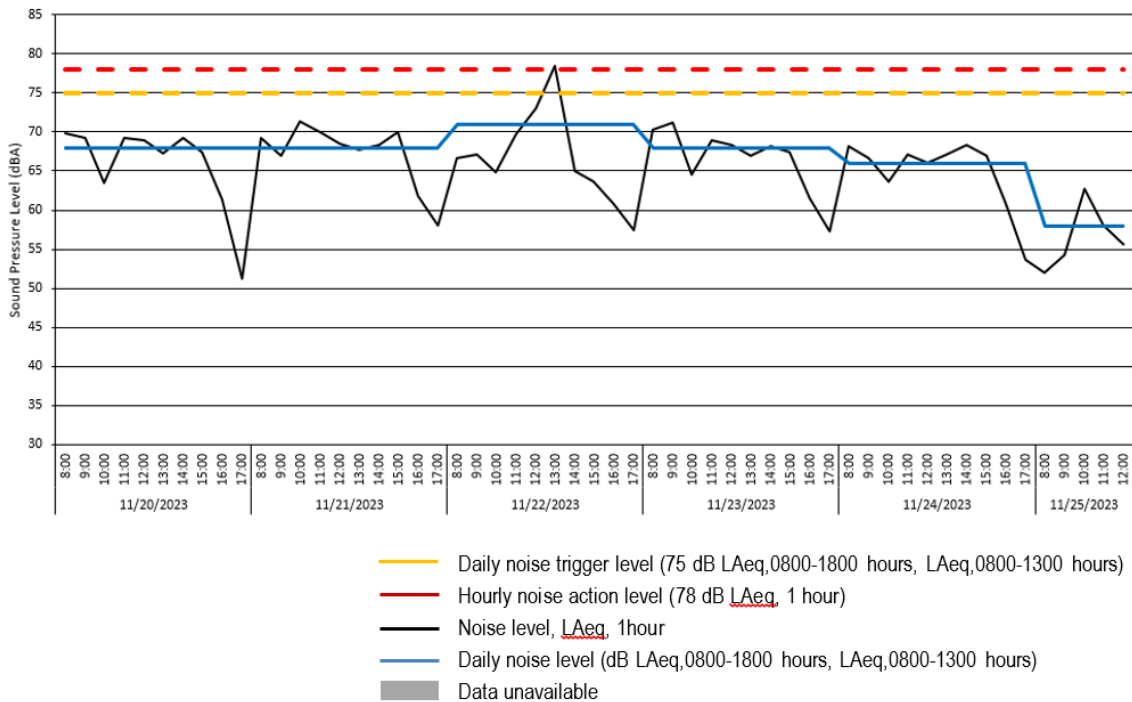
Figure 3 – Example graph of noise monitoring from Holloway Park

- 4.7 The vertical axis shows the measured noise levels (dB LAeq).
- 4.8 The horizontal axis shows the date and time of the measurements.
- 4.9 The solid blue line shows the daily measured noise level. For weekdays, this is a 10 hour value between 0800 and 1800 hours. For Saturdays, this is a 5 hour value between 0800 and 1300 hours.

- 4.10 The yellow dashed line shows the daily noise limit. In the example above there are no occasions where the blue line has gone above the yellow dashed line which means there were no exceedances of the daily noise limit.

- 4.11 The solid black line shows the hourly measured noise levels throughout the monitoring period.
- 4.12 The red dashed line shows the hourly noise limit. In the example above there is one occasion where the black line has gone above the red dashed line which means there was one exceedance of the hourly noise limit which occurred at 1300 hours on 22/11/2023.

4.14 Any gaps in the measured data will be denoted by a solid vertical shaded grey area as show in the figure above. Gaps in data will usually be caused by either power outages or a loss in mobile signal.

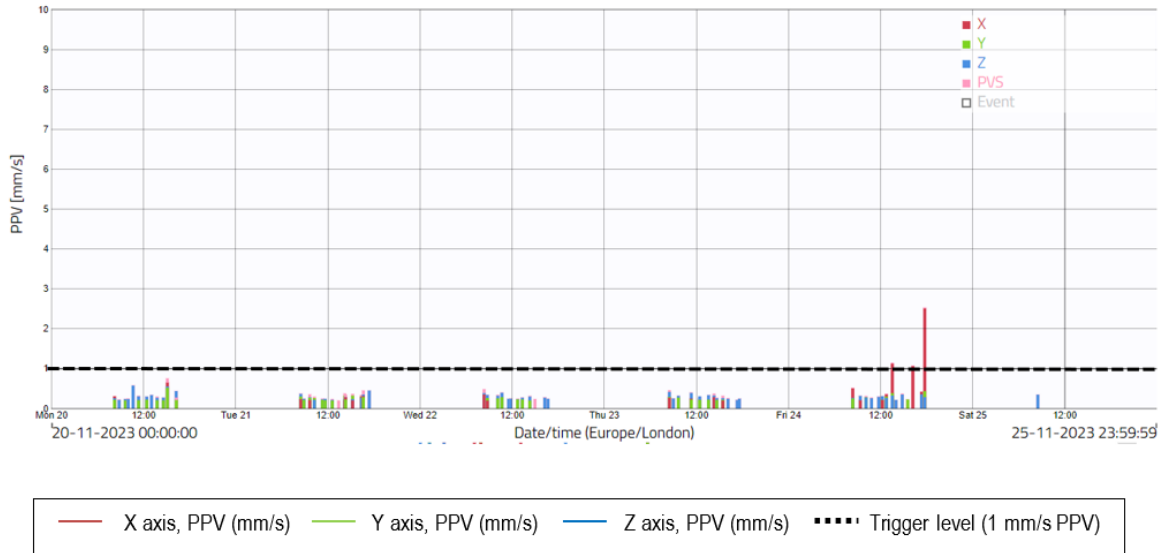
Figure 4 – Example graph of vibration monitoring from Holloway Park

4.15 The vertical axis shows the vibration (Peak Particle Velocity, PPV) measured in millimetres per second.

4.16 The horizontal axis shows the date and time of the measurements.

4.17 The solid red, green and blue lines show the measured horizontal and vertical PPV.

4.18 The black dashed line shows the vibration limit. In the example above there were exceedances of the vibration limit that occurred on Friday 24th November.

4.19 Any gaps in the measured data will be denoted by a solid vertical shaded grey area as show in the figure above. Gaps in data will usually be caused by either power outages or a loss in mobile signal.

4.20 It should be noted that the weekly vibration summary graph will be compressed as data is recorded every minute onsite and this cannot be shown completely on a single graph at a weekly resolution.

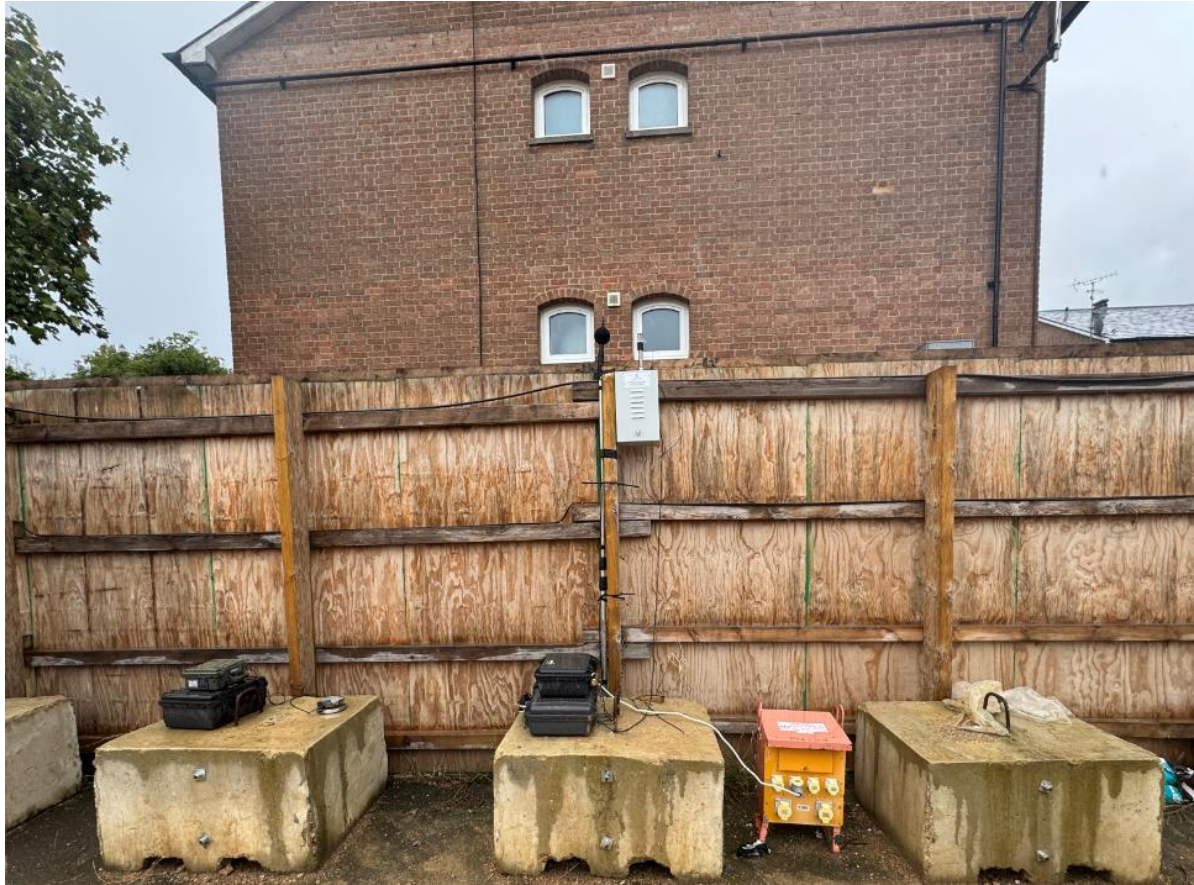
Location 3 – Dust, Noise and Vibration – northeastern boundary facing residential uses within Holloway Estate

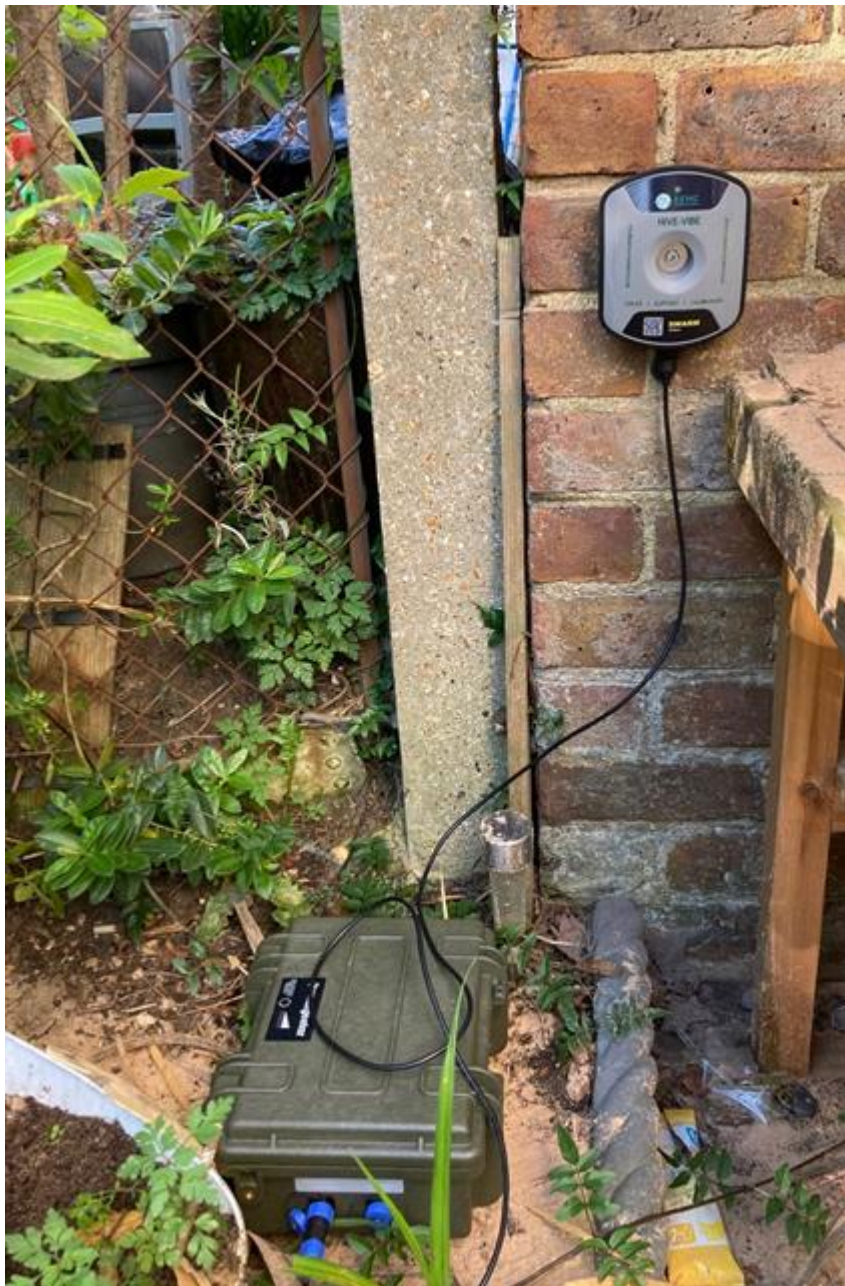
Location 4 – Vibration – previously attached to rear garden fence of one of the dwellings on Trecastle Way (from August 2023 until May 2024 – it has since been relocated to within the site boundary)
