Holloway Park, London

Construction Monitoring Report

Client:	London Square
Ref:	CM113-22405-R0
Date:	15 August 2025
Note by:	Anthony Coraci, MSc DipIOA MIOA, Senior Acoustics Consultant

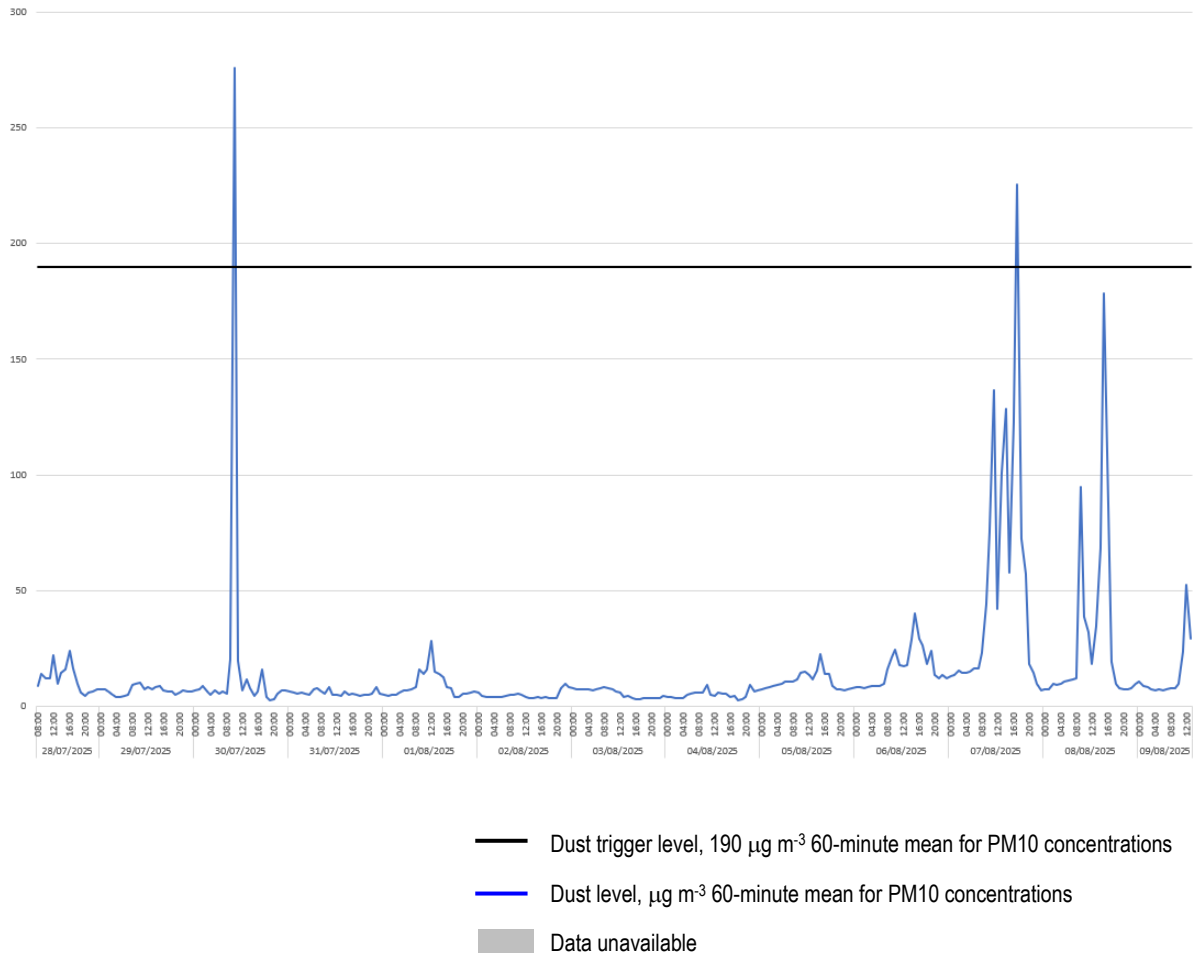
Location 1 (meter ref. TNO4728)

3.2 There was 100% data coverage during the monitoring period. There were two exceedances of the dust trigger of 190 μg m^{-3} recorded at this location during construction hours. These occurred on:

- Wednesday 30th July, at 10:00, with a measured level of 275.9 μgm^{-3}; and,
- Thursday 7th August, at 17:00, with a measured level of 225.7 μgm^{-3}.

3.3 Based on discussions with site management, this was understood to have been caused by work taking place at Block C, including striking work. The current warm, dry weather conditions are likely to have contributed to the spread of dust across the site. It is recommended that site management continue regular water suppression across relevant areas to minimise the risk of further exceedances.

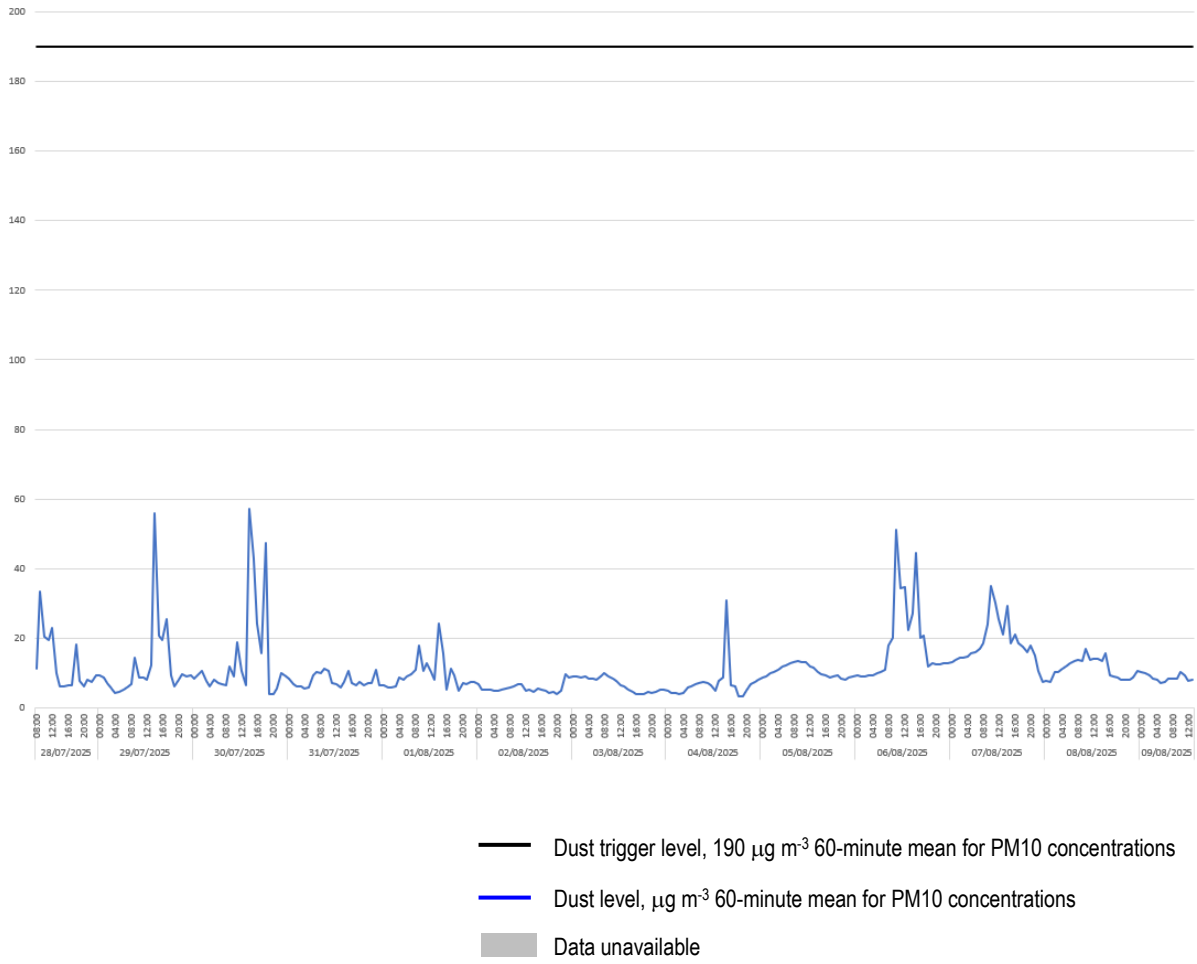
Location 2 (meter ref. TNO4778)

3.4 There was 100% data coverage during the monitoring period covered by this report. There were no exceedances of the dust trigger of 190 μg m^{-3} recorded at this location during construction hours.

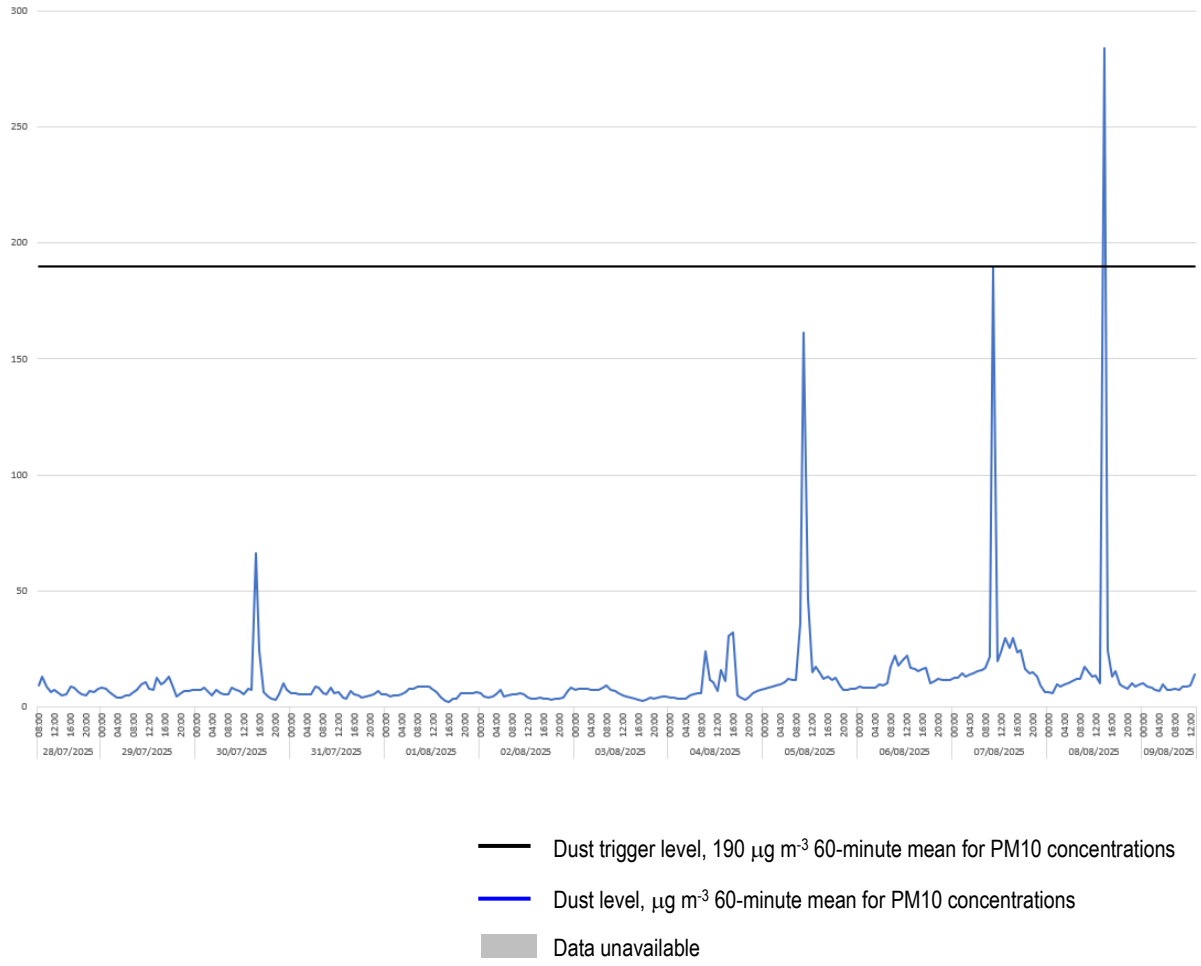
Location 3 (meter ref. TNO4729)

3.5 There was 100% data coverage at Location 3 during construction hours for the monitoring period covered by this report. One exceedance of the project dust trigger level of 190 µg m^{-3} was recorded at this location during the monitoring period covered by this report. This occurred at 14:00 on Friday 8th August, with a measured level of 284.2 µgm^{-3}. Based on discussions with site management, this is likely to have been caused by parking bay formation work taking place within the vicinity of the monitoring location. This will continue to be monitored.

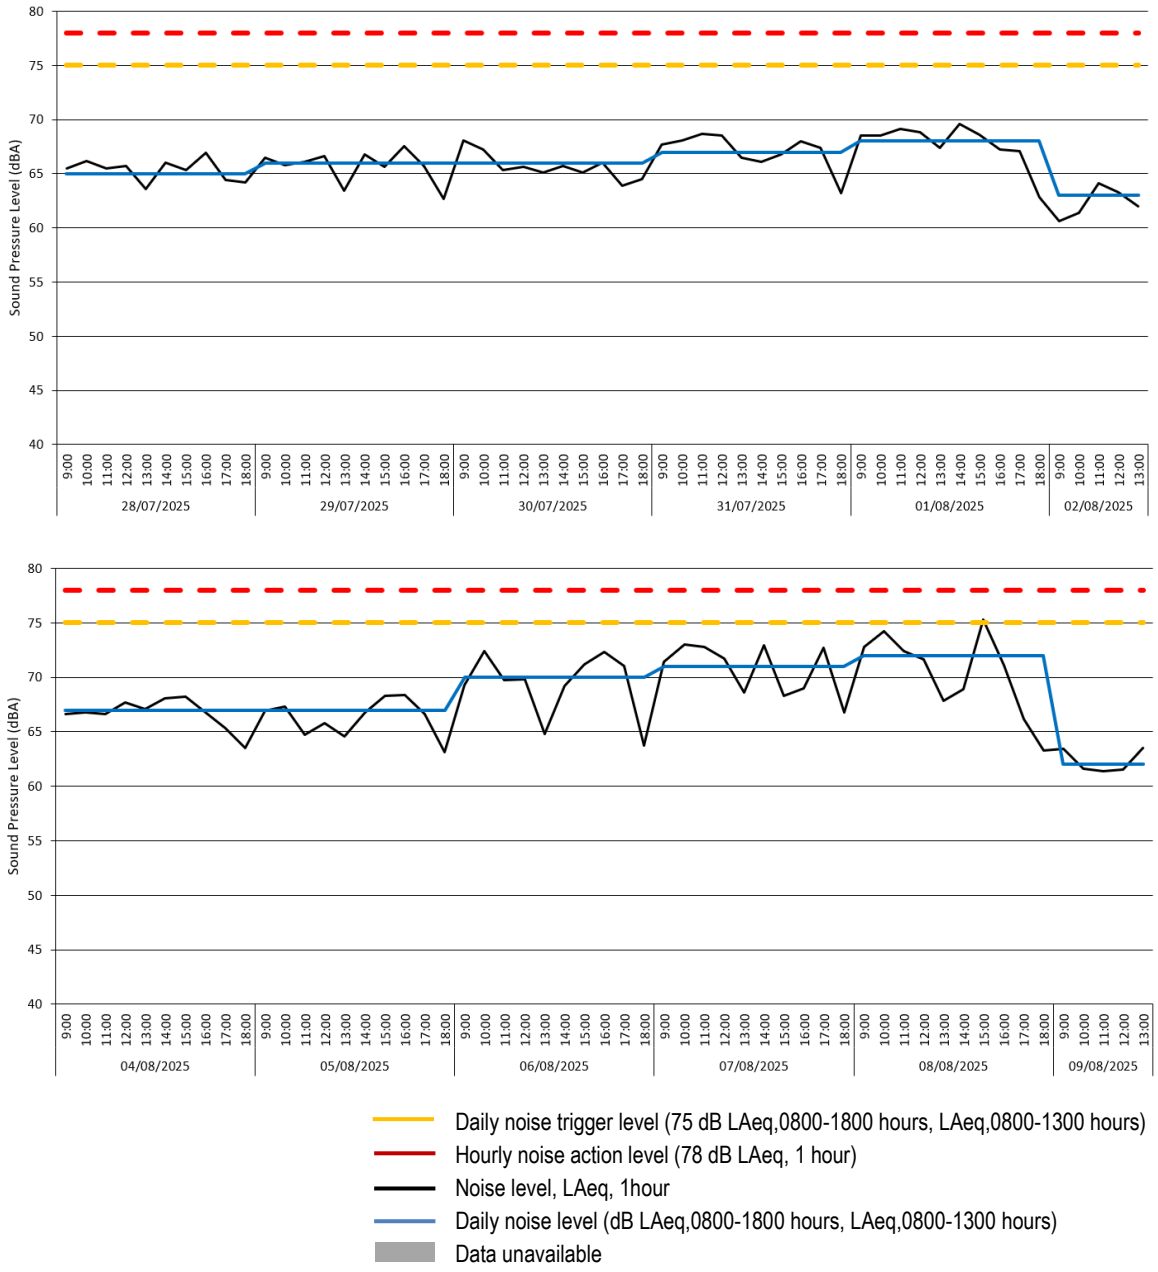
Location 1 (meter ref. SMENK-9E5DF) – Time History Data

3.6 There was 100% data coverage at Location 1 during construction hours for the monitoring period covered by this report. There were no exceedances of the daily noise trigger level (75 dB LAeq,T) or hourly noise action level (78 dB LAeq,1 hour) at this location for the monitoring period covered by this report.

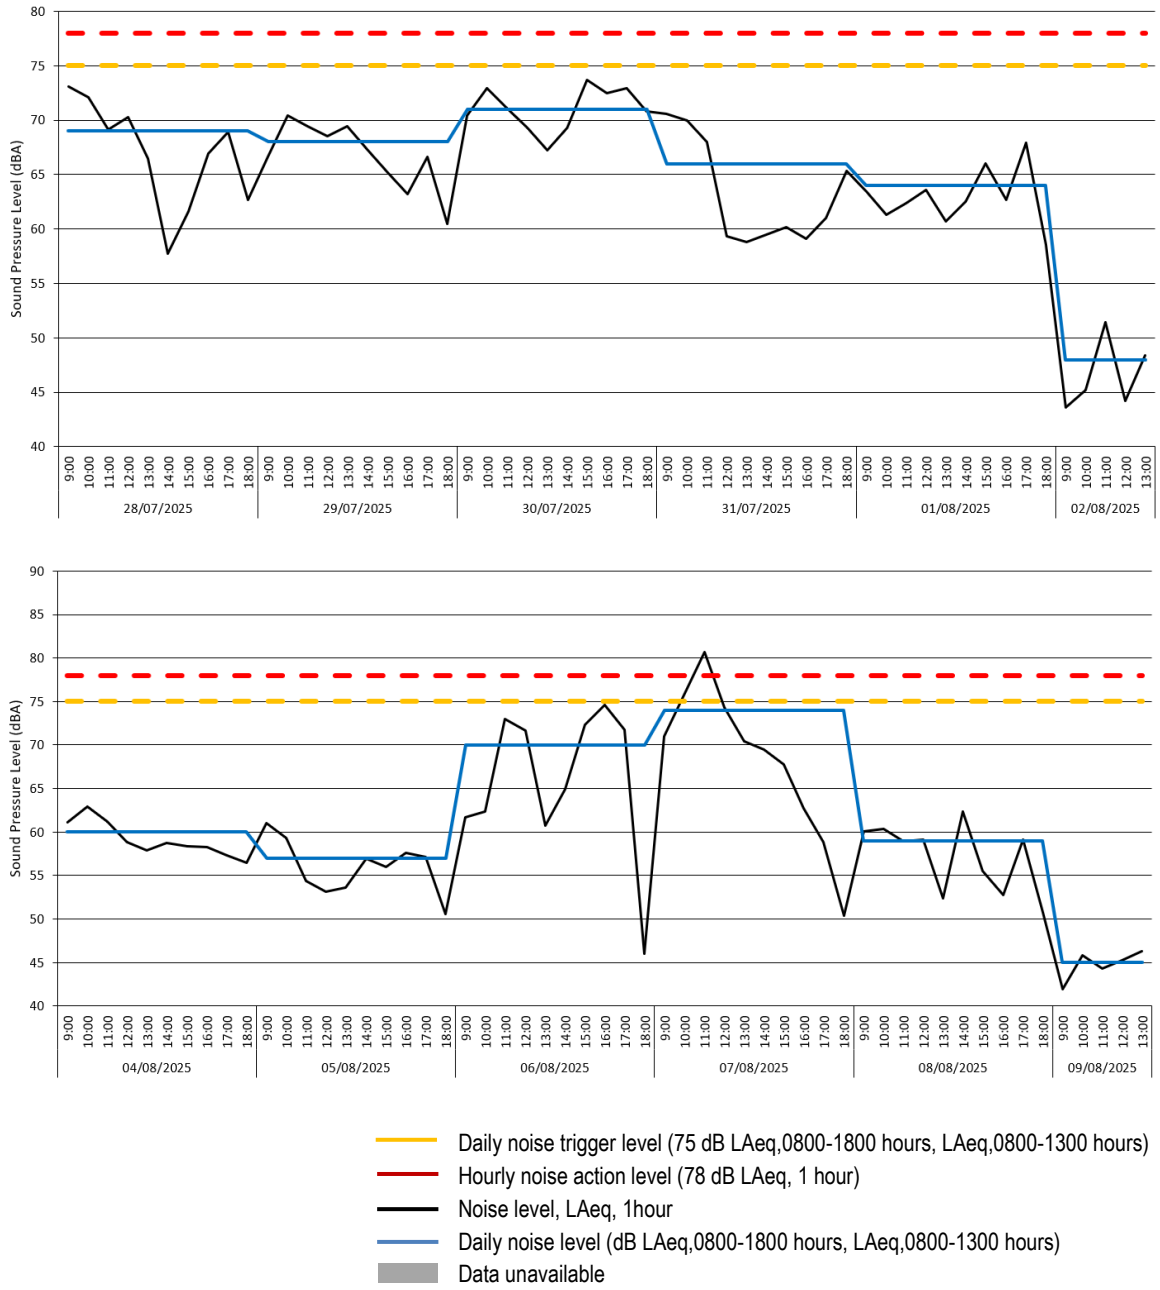
Location 2 (meter ref. VFHMP-7XSY7) – Time History Data

3.8 There was 100% data coverage at Location 2 during construction hours for the monitoring period covered by this report. There was one exceedance of the hourly noise action level, which occurred at 11:00 on Thursday 7th August, with a measured noise level of 80.7 dB LAeq,1hr. Based on discussions with site management, this was understood to have been caused by work taking place within the proximity of Block E; in particular, the groundworks team who have been working on the nearby water pipe installation. There were no exceedances of the daily noise trigger level (75 dB LAeq,T) at this location during the monitoring period covered by this report, including on the day during which the hourly noise action level was exceeded.

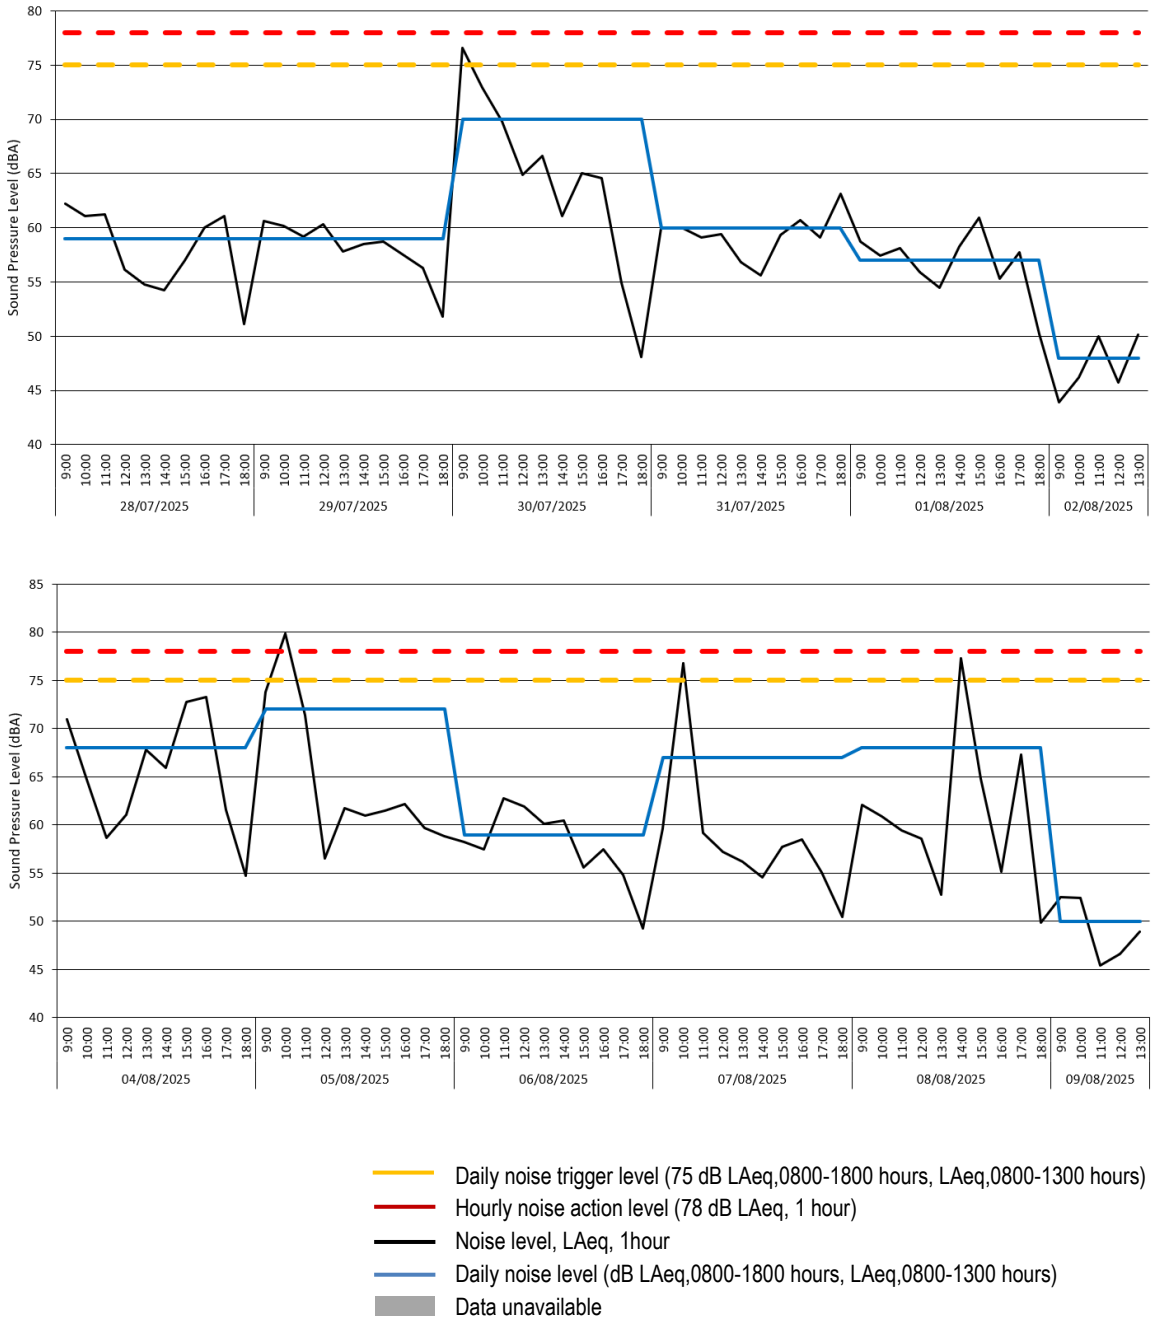
Location 3 (meter ref. P5DLY-N3J7A) – Time-history graph

3.9 There was 100% data coverage at Location 3 during construction hours for the monitoring period covered by this report. There were no exceedances of the daily noise trigger level (75 dB LAeq,T) at this location for the monitoring period covered by this report. There was one exceedance of the hourly noise action level (78 dB LAeq,1 hour), which took place at 10:00 on Tuesday 5th August, with a measured noise level of 79.9 dB LAeq,1hour. Based on discussions with site management, this is likely to have been caused by parking bay formation work taking place within the vicinity of the monitoring location. It is positive that the daily noise trigger level was not exceeded.

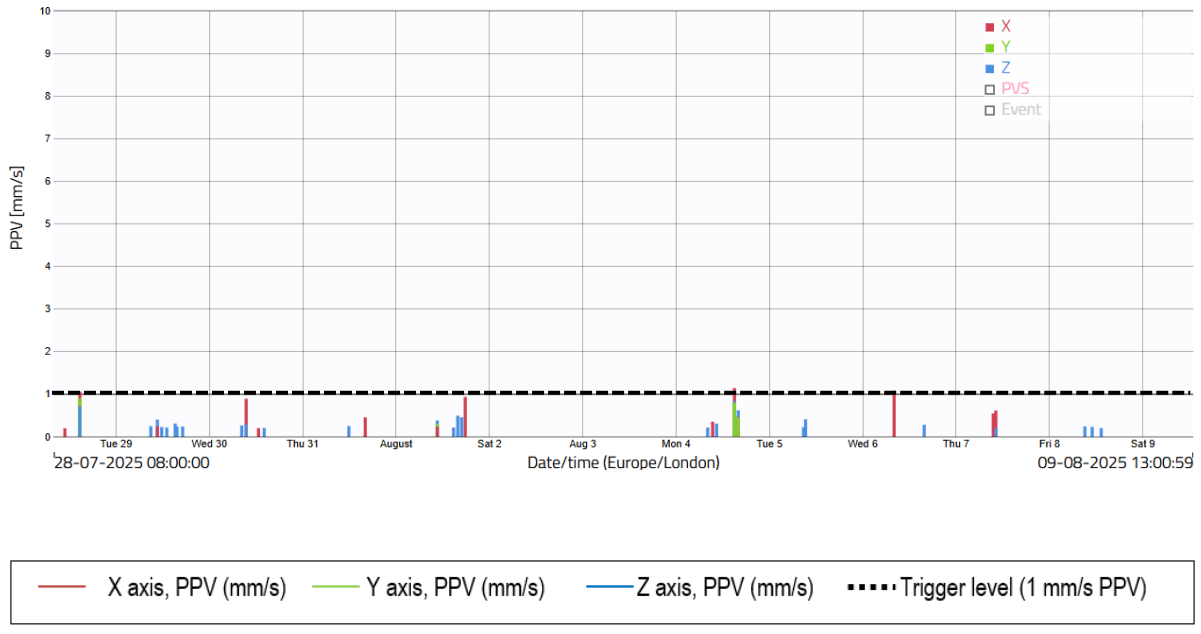
Location 1 (meter ref. PIJIVI) – Time history graph

3.10 There was 100% data coverage at Location 1 during construction hours for the monitoring period covered by this report. There were three exceedances of the project vibration trigger level of 1.0 mm/s PPV, as shown in the raw data and graph above. This occurred at 13:28 on Monday 4th August, with a recorded level of 1.2 mm/s PPV. Based on discussions with site management, this was understood to have been caused by work taking place at Block C, including scaffolding work.

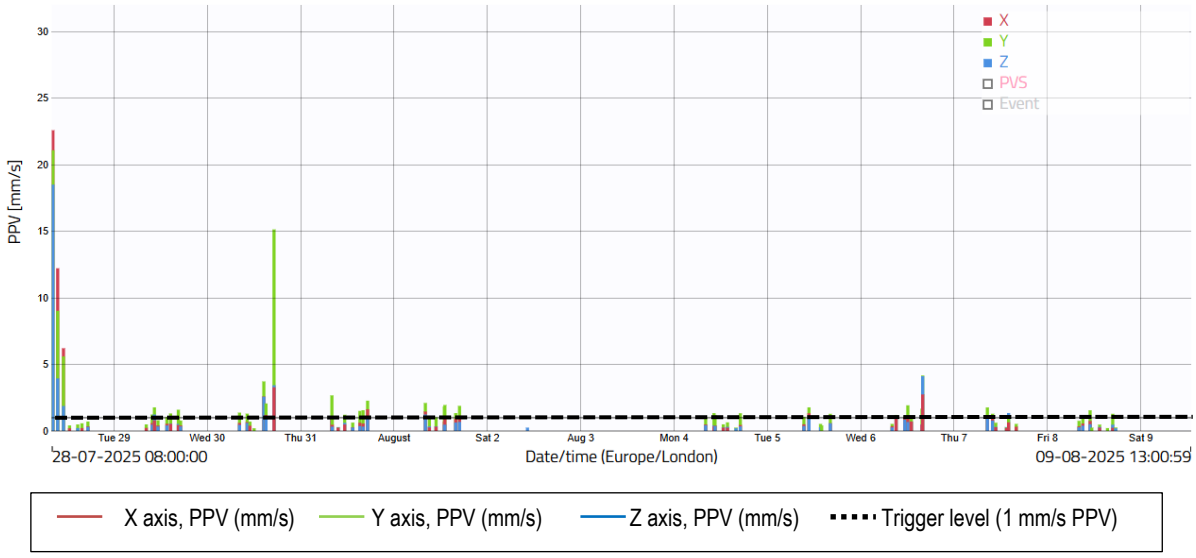
Location 2 (meter ref. LEQUMO) – Time-history graph

3.12 There was 100% data coverage at Location 2 during construction hours for the monitoring period covered by this report. There were 276 exceedances of the project vibration trigger level of 1.0 mm/s PPV, as shown in the raw data and graph above. The highest recorded vibration level took place on Monday 28th July at 08:17, with a recorded level of 22.6 mm/s PPV.

3.13 Based on discussions with site management, this was understood to have been caused by work taking place within the proximity of Block E; in particular, the groundworks team who have been working on the nearby water pipe installation. This will continue to be monitored.

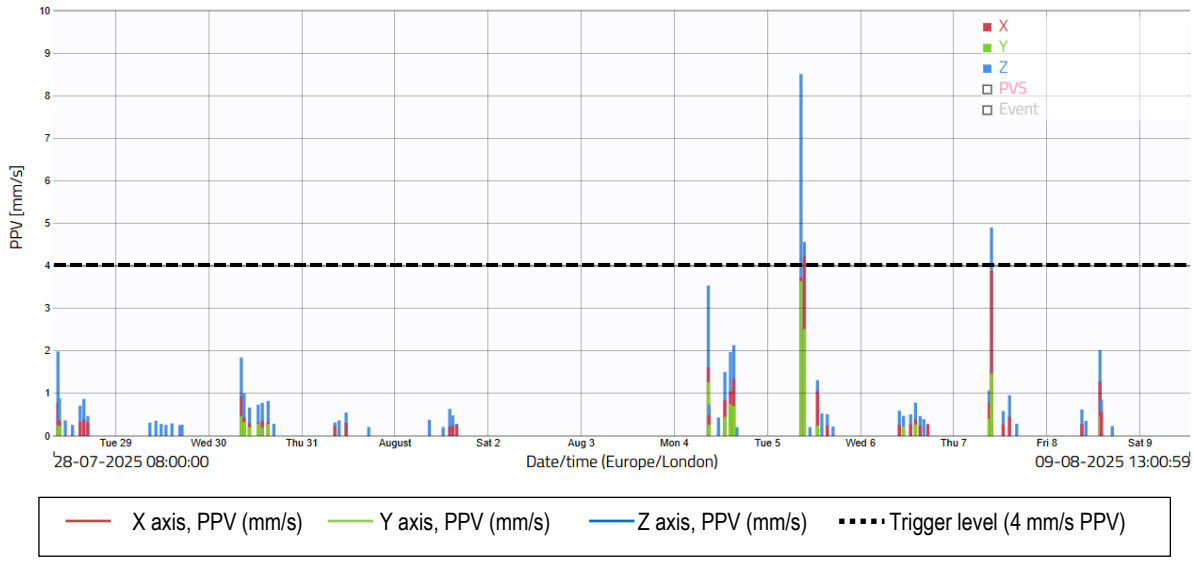
Location 3 (meter ref. RIYORU) – Time-history graph

3.14 There was 100% data coverage at Location 3 during construction hours for the monitoring period covered by this report. There were 13 exceedances of the vibration trigger level (4 mm/s PPV) at this location during the monitoring period. The highest of these occurred on Tuesday 5th April at 08:33, with a measured level of 8.5 mm/s PPV. Based on discussions with site management, it is understood that this was caused by the parking bay formation in front of the monitoring location. This will continue to be monitored.

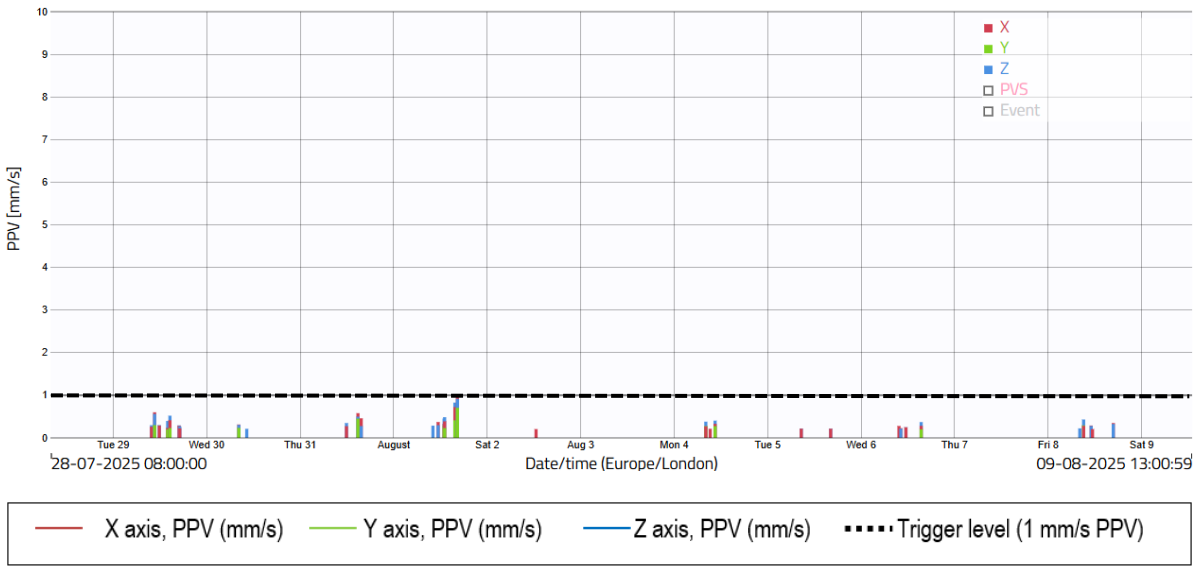
Location 4 (meter ref. TEJELU) – Time-history graph

3.15 There was 100% data coverage at Location 4 during construction hours for the monitoring period covered by this report. There was one exceedance of the project vibration trigger level of 1.0 mm/s PPV during the monitoring period covered by this report. This took place on at 16:21 on Friday 1st August. with a measured level of 1.01 mm/s PPV. Based on discussions with site management, this was understood to have been caused by work taking place within the proximity of Block E; in particular, the groundworks team who have been working on the nearby water pipe installation. This will continue to be monitored.
